## Analysis of the end-of-life the front suspension beam of a vehicle

Sławomir Kowalski<sup>a</sup>, Kazimierz Opoka<sup>a</sup>, Józef Ciuła<sup>a</sup>

<sup>a</sup>State University of Applied Sciences in Nowy Sącz, ul. Zamenhofska 1a, 33-300 Nowy Sącz, Poland

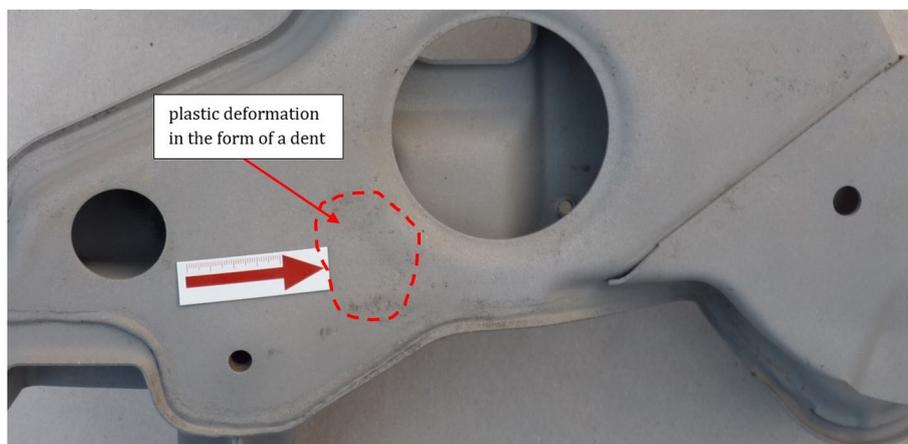
The macrographic observations of the beam plating demonstrated wear in the form of plastic deformations of a peculiar arched shape (Fig. 4). The range of those deformations was insignificant and had no influence on the change of the original beam shape. Linear scratches of the plating as well as hairline cracks of the minimum depth in the beam plating were also noted. The cause of that kind of damage is sought in the contact of that element of the chassis with items making the road dirty, such as sand particles, stones etc., which may have fallen down from aggregate-carrying vehicles. Such items may have also been brought onto the road by vehicles joining the traffic from a construction area or aggregate collection points. Damage described above was located at the lower beam plating, where friction or impact contact with obstacles present on the road may take place.

Fig. 4. Beam damage in the form of plastic deformation

That damage, consisting in plastic deformations, did not affect driving safety and was easy to locate during technical inspections, that is why a detailed analysis of that damage is omitted in the further part of this article. The main focus was on the wear following from the natural operation process, which cannot be verified and removed during diagnostic tests.

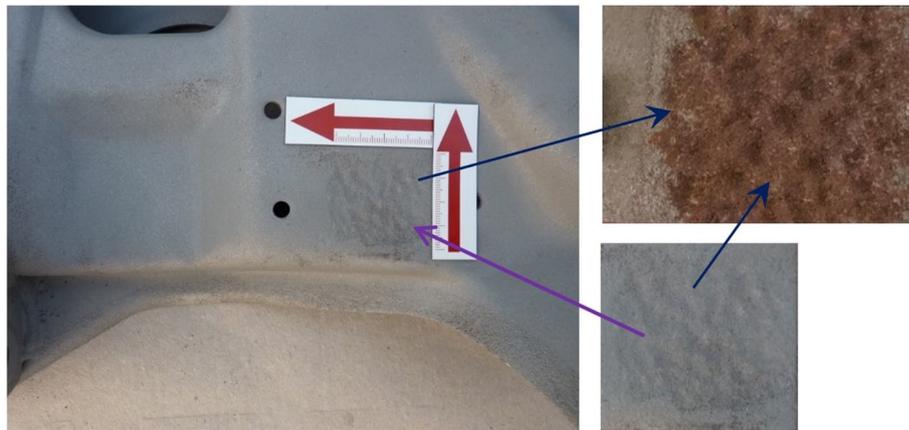
The detailed macrographic observations of the beam surface demonstrated peculiar changes of the surface profile at the point of connection of the stabiliser rod (Fig. 5). Visible wear traces occupy a square area of 16 cm<sup>2</sup>. The wear-affected area is distinguished by high waviness and a change of the top layer structure.

Fig. 5. Front suspension beam fragment with visible wear traces

It is appropriate to think that fretting is highly likely to be noticeable at the point of connection of the stabiliser with the front suspension beam. To confirm that theory, however, further tests and analyses are necessary. The required condition for the development of fretting wear in the case of the front suspension beam and stabiliser rod tribological kinematic pair was fulfilled.

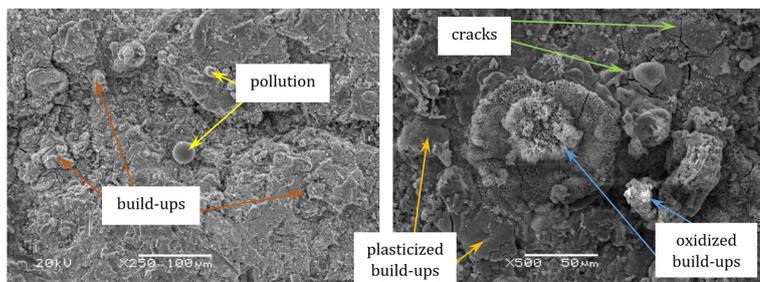
The microscopic observations confirmed the macroscopic observations suggesting that the main damage of the beam at the point of mounting the stabilisers rod is constituted by corrosion or fretting wear. The following features were observed: fatigue crack, corrosion pits, hairline cracks and material build-ups, which become plasticised and crumbled.

Fig. 6. Sample SEM images of the wear products on the front suspension beam surface

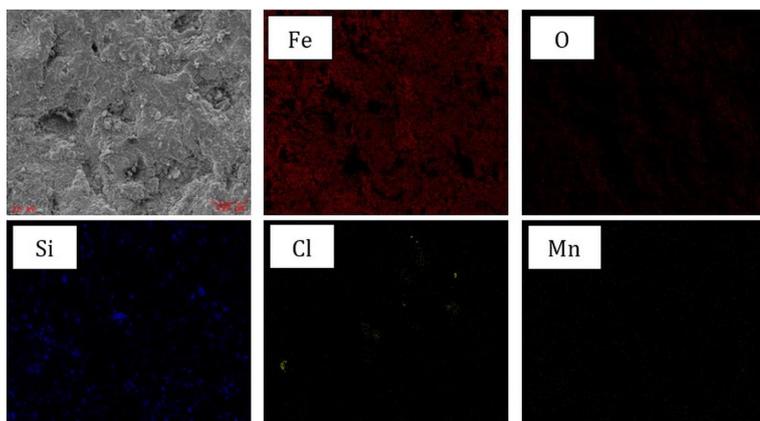
Fig. 7. Surface analysis of the chemical composition of the front suspension beam wear products

ence of iron, oxygen, silicon, chlorine and manganese atoms. The spot analysis of the chemical composition at another place also demonstrated the presence of the same elements. Iron and oxygen atoms prevail in the chemical composition of wear products. Such a result is the evidence of the penetration of oxygen in between the mating surfaces, which leads to surface oxidation and to the initiation of a phenomenon similar to corrosion. In the case of fretting wear, iron and oxygen atoms are the prevailing components of the wear products, too [1, 21, 29]. Thus, the thesis that the suspension system elements may be exposed to fretting confirmed in this case as well.

The analysis of the chemical composition of wear products demonstrated the presence of silicon and chlorine atoms. Silicon is the evidence of the presence of sand or other impurities from the road in the space between the beam and stabiliser rod mounting. This also proves the fact that the vehicles were moving on sand or unpaved roads. During vehicle operation, sand grains trapped in the space between the mating elements move in various directions thus causing, with the passage of time, the development of friction wear and surface scratches on the micro scale, which may also initiate the development of fatigue cracks. The presence of chlorine atoms confirms that the vehicles were moving on roads at which slipperiness was reduced by means of road salt. During suspension system deflection, salt present on the road would penetrate into the space between the beam and stabiliser rod mounting. Road salt which will not be removed from that space, will accelerate wear processes.

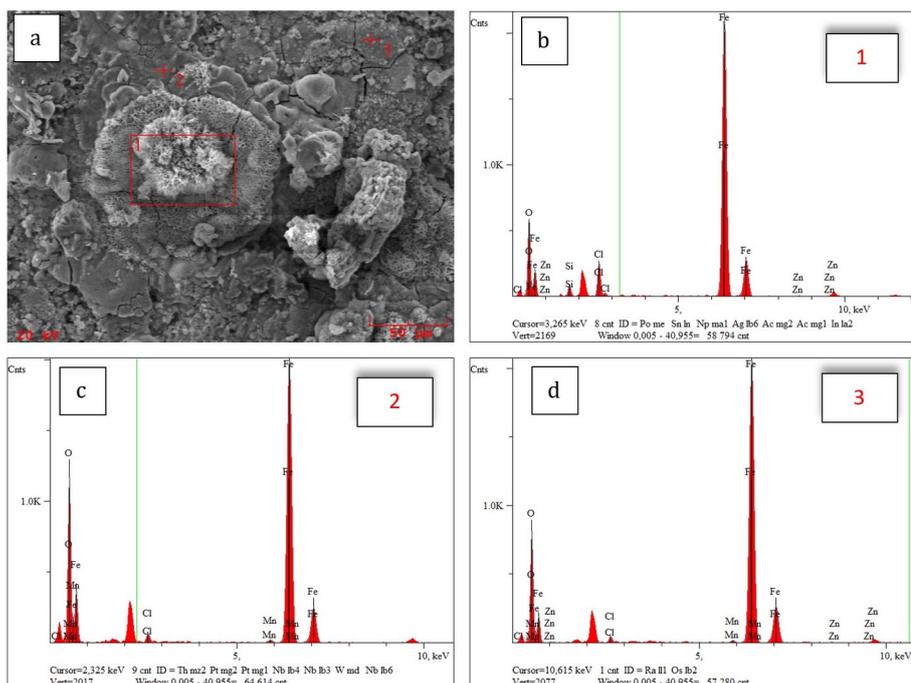
Fig. 8. Spot analysis of the chemical composition: a) SEM image, b) radiation spectrum peculiar for point 1, c) radiation spectrum peculiar for point 2, d) radiation spectrum peculiar for point 3

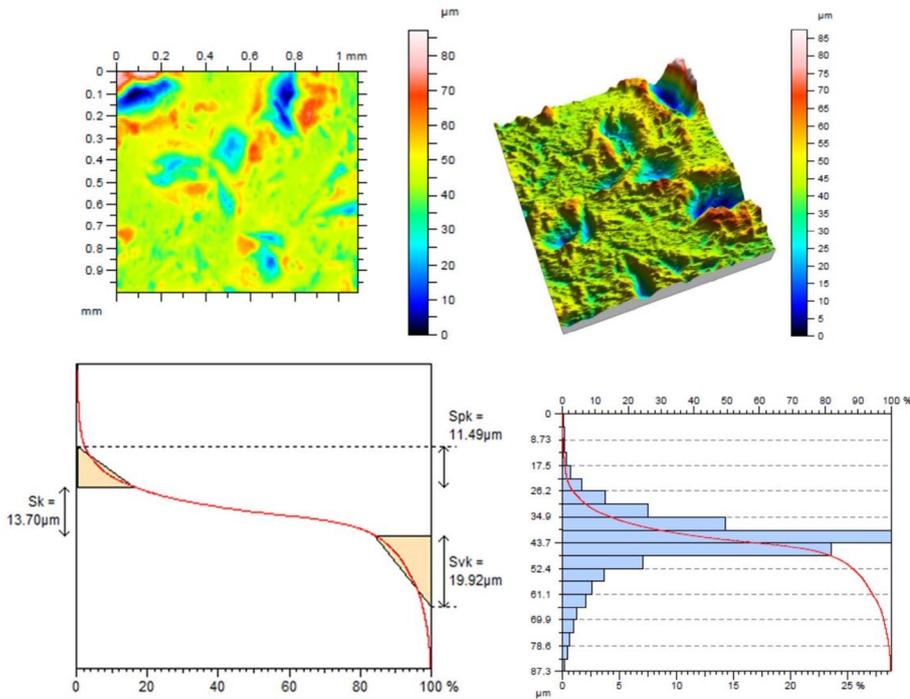
Fig. 9. The area without wear traces in profilometrical analysis

When analysing the obtained values of the parameters for the area not affected by wear, it may be noticed that the maximum surface height Sz is 85.60 μm, the arithmetic mean surface height Sa=6.496 μm, the maximum peak height Sp=41.98 μm, the maximum valley depth Sv=43.63 μm and the root mean square height Sq=9.709 μm. Quite quick fading of the ACF function (the Sal parameter) is the evidence of the dominant share of the random component in the surface geometry structure. The distribution of the data for the local summits is the normal distribution with high kurtosis Sku=6.022 and insignificant negative skewness Ssk=-0.7271, which points out to the surface with a plateau shape.

The uniform structure of the top layer was evidenced in the regions without damages. This was confirmed by the value of the texture aspect ratio which takes Str=0.7015 (the isotropy level 70.15%).

When analysing hybrid parameters, attention should be paid to the high local summit density (Sds= 1088 1/mm<sup>2</sup>) and the large fractal dimension (Sfd=2.481). The surface has the smallest core fluid retention index (Sci = 1.33) and the highest valley fluid retention index (Svi=0.197) given the bearing index Sbi=0.3539 compared to the surfaces affected by corrosion.

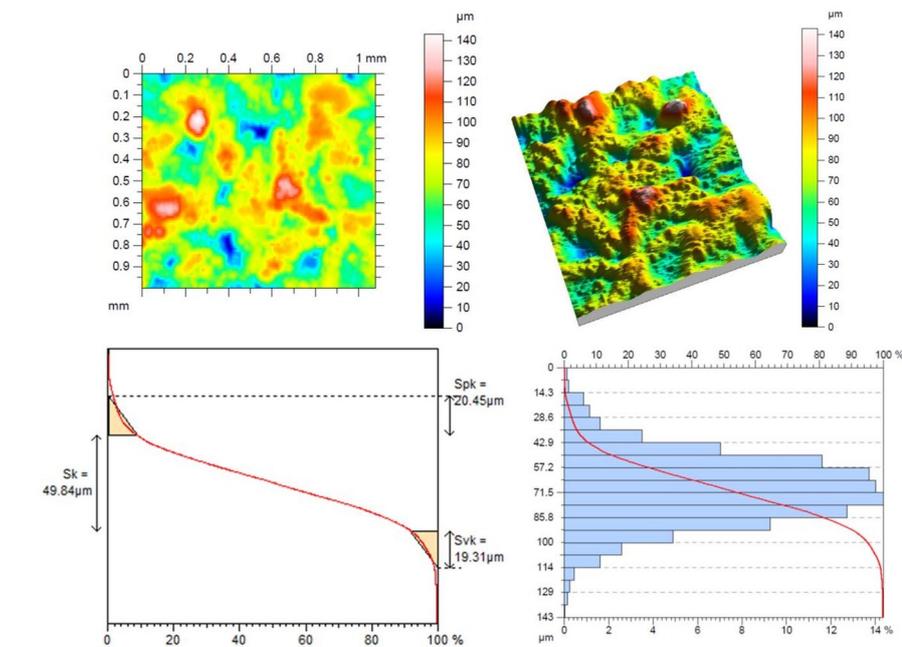
Fig. 10. The area affected by wear in profilometrical analysis

In the case the area affected by wear, it may be noticed that the maximum surface height Sz is 143.2 μm, the arithmetic mean surface height Sa=15.04 μm, the maximum peak height Sp=69.68 μm, the maximum valley depth Sv=73.52 μm and the root mean square height Sq=18.93 μm.

All the height parameters even doubled in comparison with the surface not affected by corrosion. The quickly diminishing autocorrelation function (Sal=0.10691 mm) is peculiar to random structures.

The surface affected by corrosion has a random isotropic structure, as evidenced by the value of the texture aspect ratio Str=0.8574 (the isotropy level 85.74%).

The local summit density decreased by the factor of two compared to the surface not affected by corrosion (Sds= 531.13 1/mm<sup>2</sup>). A large fractal dimension (Sfd=2.382) was also obtained. The root mean square gradient was equal to Sdq=0.664, the arithmetic mean summit curvature reached Ssc=93.03 1/mm and the developed interfacial area ratio obtained Sdr=20.20% doubled, confirming greater surface roughness.

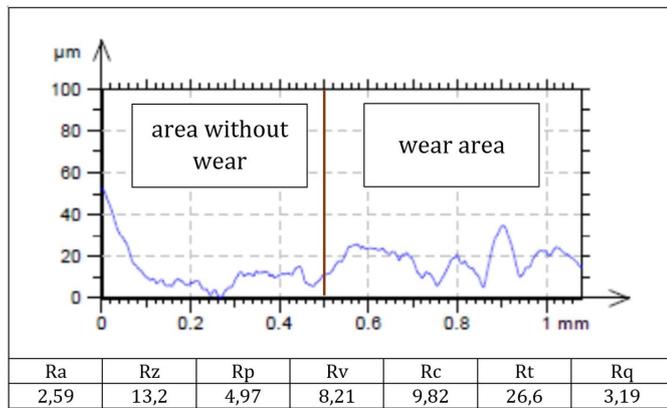
The 2D course of the profile of the beam surface comprising the area with and without wear (Fig. 11) confirms the loss of the material as a result of cyclical loading, the continuous generation of wear products in the tribological kinematic pair (the joint between the suspension beam and the stabiliser rod mounting), which products, during vehicle operation, move over the entire joint length thus causing surface scratches or the formation of micropits and microabrasion. Those phenomena are conducive to fretting wear development.

Fig. 11. 2D roughness parameters of the surface comprising the area with and without wear

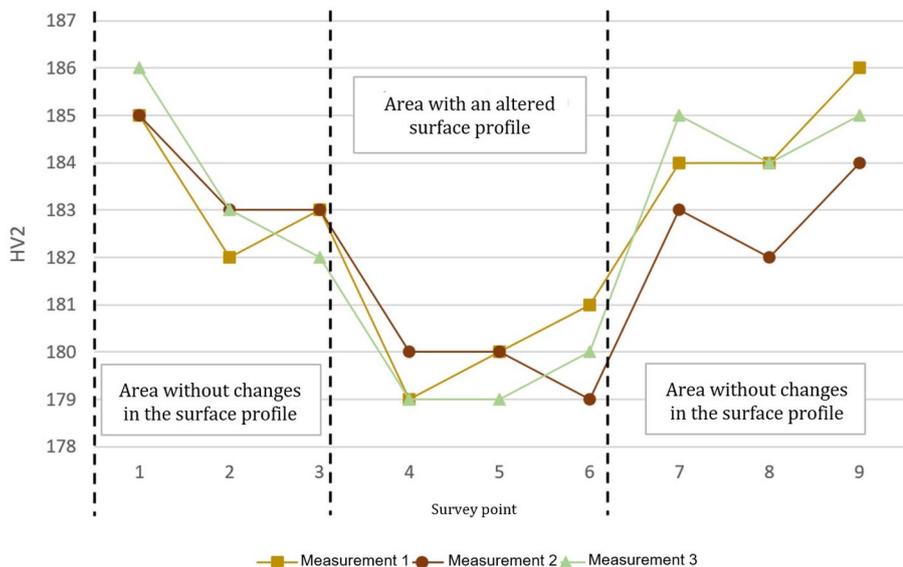
The measured beam surface hardness varies from 179 to 186 HV2. Following the analysis of the beam hardness results, the decrease of surface hardness in the area affected by wear can be noticed. In that area, surface hardness was equal to 179-181 HV2. Steel hardness reduction may be the cause of the reduced resistance of the element to friction wear and plastic deformations, which are conducive to adhesion processes. Those factors create a suitable environment for the development of fretting wear, whose consequence is the development of fatigue wear and the cracking of the element.

Fig. 12. Suspension beam hardness measurement results

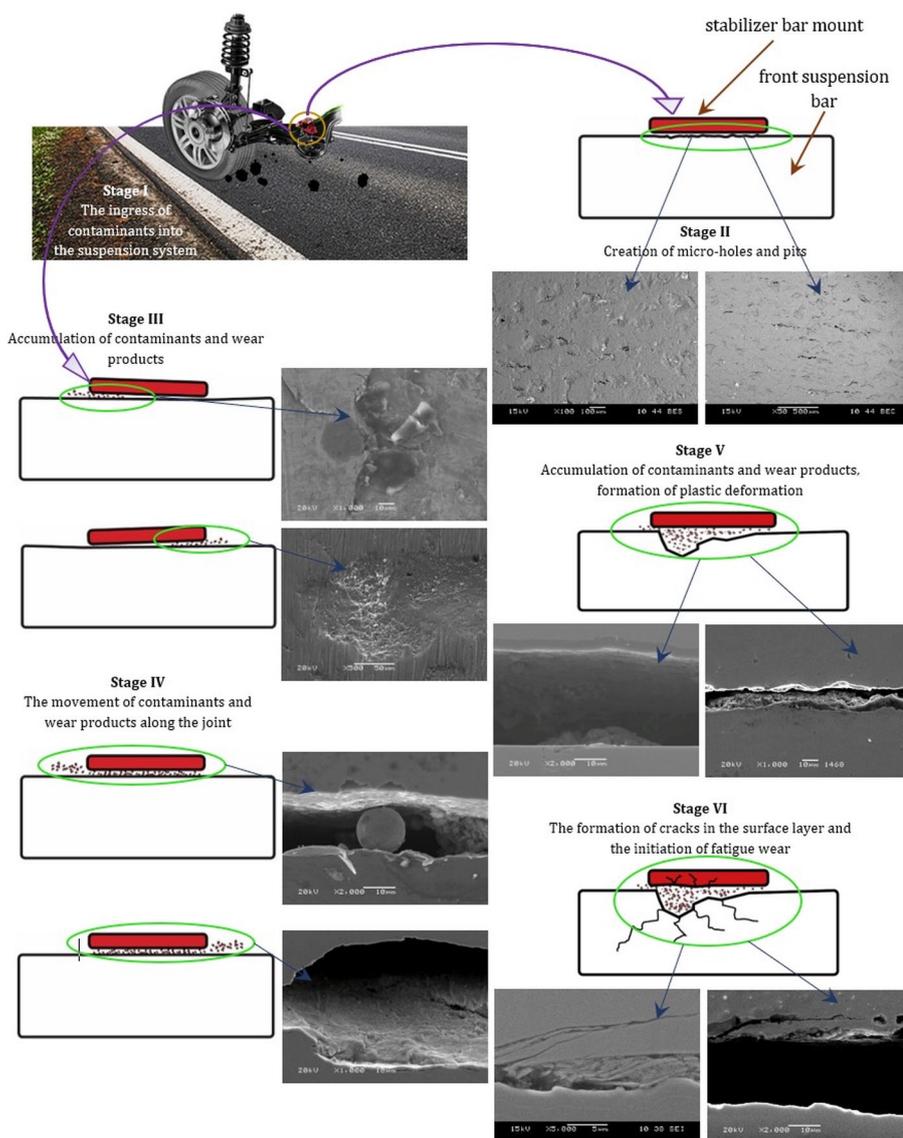
Factors related to the loading from the vehicle weight as well as dynamic factors connected with road conditions act on the beam and on the remaining elements of the suspension system of a moving vehicle. Due to the cyclical activity of those factors, the microdeflection of the mating elements and, at the same time, their static microdisplacement, takes place. This situation is conducive to a change of the profile of the elements' surface and, as a result of friction, surface micropullouts, microholes and micropits will come into being at the beam surface.

Trapped impurities will move along the joint and cause the degradation of the elements of the tribological kinematic pair as a result of abrasion. As a result of that activity, microholes and micropits become deeper and abrasion traces appear. In the deeper microholes, more impurities and surface abrasion products will accumulate thus leading to the plastic deformation of the top layer of the elements.

Further vehicle operation will result in the rise of microcracks, which will expand in the direction of the interior of the element's top layer thus causing the development of fatigue wear and, as a consequence, the cracking of the element. Road salt and water present in the space between the elements will be conducive to the formation of corrosion centres, which are an additional burden for the tribological kinematic pair.

Fig. 13. Development mechanism of the tribological wear in the suspension beam and stabiliser tribological kinematic pair
