Michnej M, Młynarski S, Pilch R, Sikora W, Smolnik M, Drożyner P. Physical and reliability aspects of high-pressure ammonia water pipeline failures. *Eksploracja i Niezawodność – Maintenance and Reliability* 2022; 24 (4): 728–737, <http://doi.org/10.17531/ein.2022.4.13>

Physical and reliability aspects of high-pressure ammonia water pipeline failures

Maciej Michnej^a, Stanisław Młynarski^a, Robert Pilch^b, Wojciech Sikora^b, Maksymilian Smolnik^b, Przemysław Drożyner^c

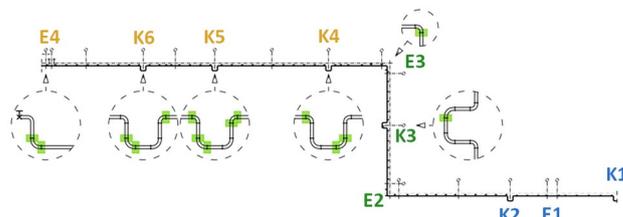
Fig. 2. Scheme of the pipeline with marked compensators (K1-6) and changes to its route (E1-4) [10]

The location of the damage may indicate the relationship of their formation with the local nature of the operation of a compensator profile. However, as shown in the scheme, the damage was not found in all of the affected areas. Therefore, the pipeline components were further tested.

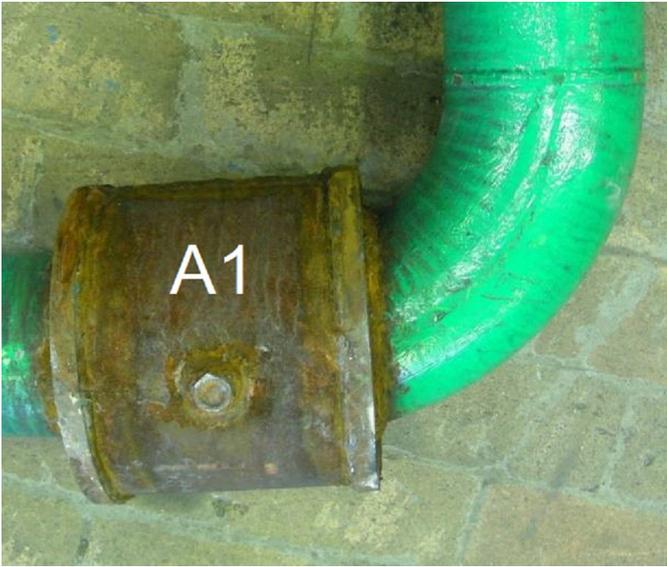
Figures 3 and 4 show selected pipeline welds tested, marked with symbols A1, B1 and C1. There were sealing bands on the welds placed on the pipeline during its operation after the occurrence of leakage. The joint A1 was sealed with a double flange with an external band.

Fig. 3. A1 joint of the high-pressure ammonia water pipeline

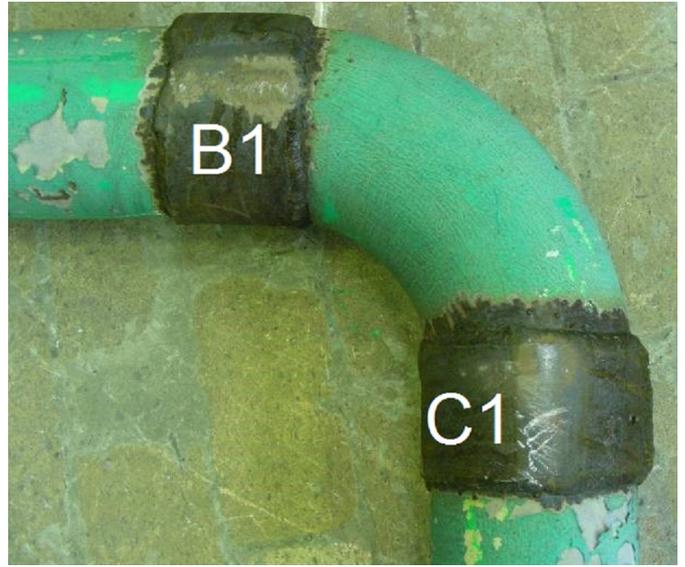
Fig. 4. B1 and C1 joints of the high-pressure ammonia water pipeline

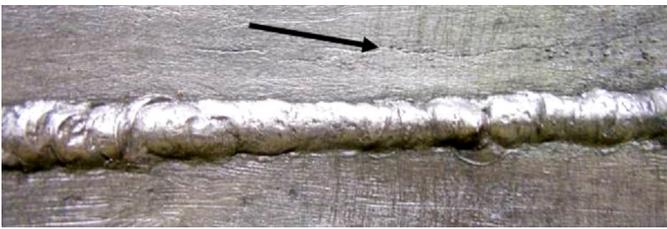
Fig. 5. View of the A1 welded joint from the root side (from the inside of the pipe)

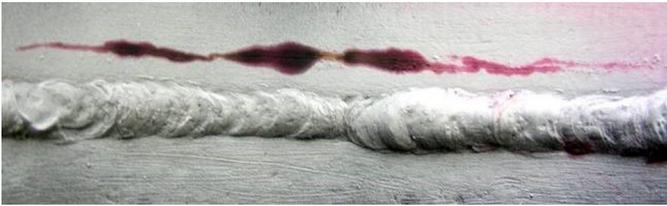
Figures 6 and 7 show the pipeline cracks visible from the inside, detected by penetrant tests. Dye penetrant has leaked to the outside of the pipe in some places.

Fig. 6. View of the A1 welded joint from the root side after penetrant testing

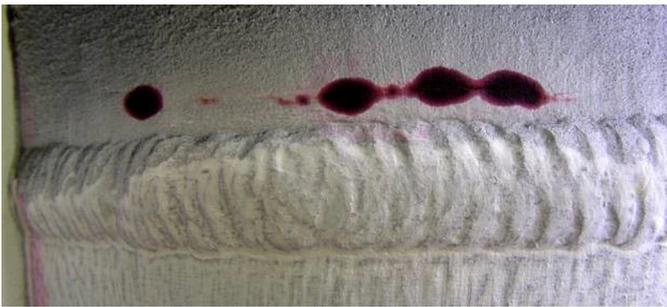
Fig. 7. View of the A1 welded joint from the face side after penetration of the dye penetrant from the inside of the pipe

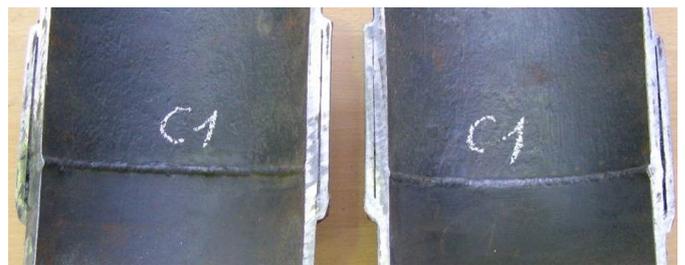
Fig. 8. shows a part of the pipeline with C1 joint after it has been cut open. Fig. 9 shows the pipeline cracks visible from the inside, detected by penetrant tests

Fig. 8. View of C1 welded joint from the root side; visible sealing band

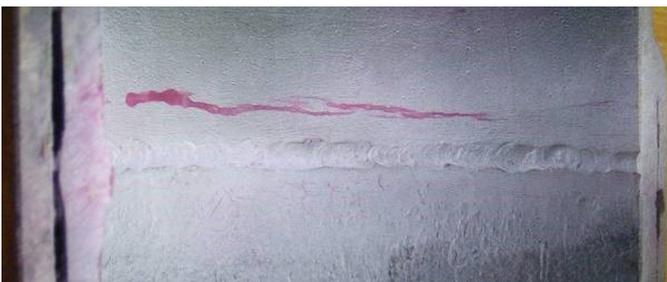
Fig. 9. View of the C1 welded joint from the inside of the pipeline after penetration testing

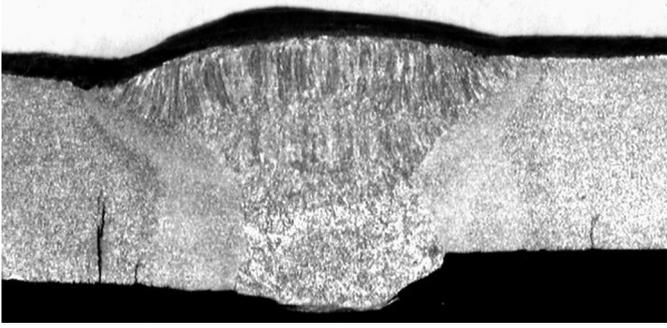
material of the pipeline in various places around the welded joints A1 and C1 are shown in Fig. 10. These cracks are located in the material outside the joint.

All the cracks in the pipeline near the joints were located in its bends and propagated from the inside of the pipeline. Where the crack reached the outer surface of the pipe, the medium penetrated the gap and the pipeline began to leak. Defects of joints visible in the cross-sections, such as shifts of the joined edges, may be of significant importance for the operation of the joint and the occurrence of the observed defects.

Fig. 10. Cross-sections of A1 (left) and C1 (right) welded joints

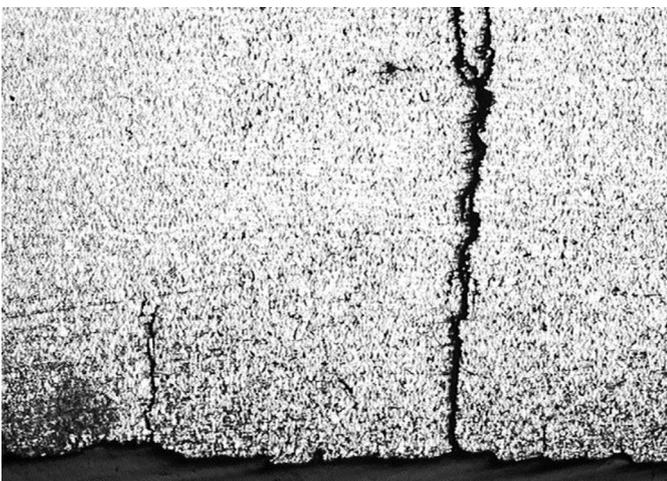
Fig. 14. Crack in the bend material in the vicinity of the A1 welded joint. 100x magnification, nital etching

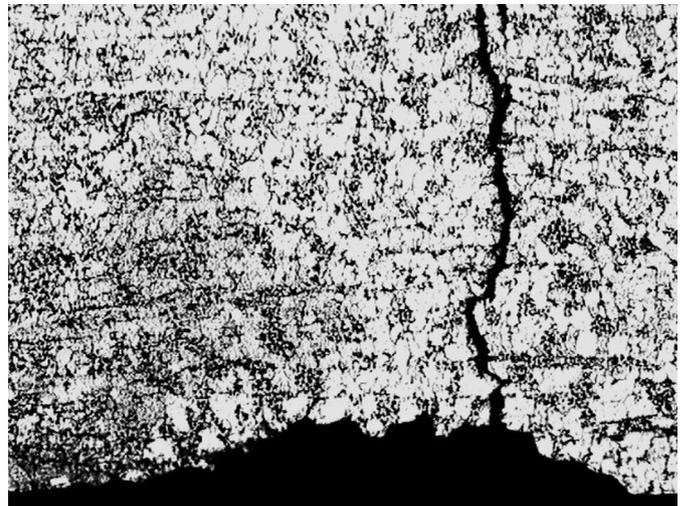
Fig. 15. Crack in the bend material in the vicinity of the C1 welded joint. Approx. 50x magnification, nital etching

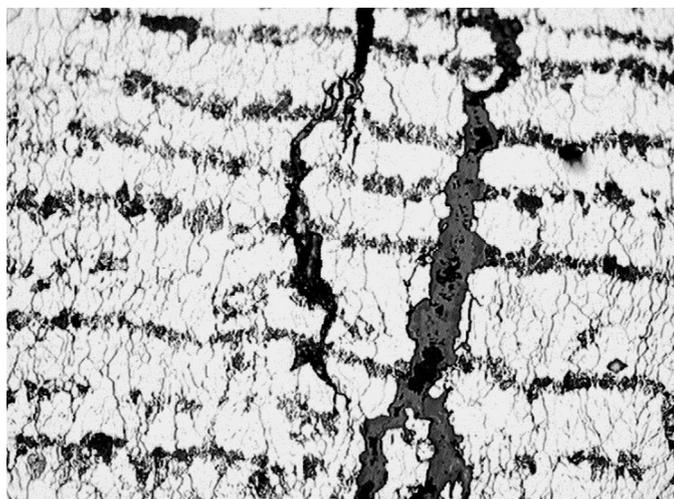
Fig. 16. Crack in the bend material in the vicinity of the C1 welded joint. Approx. 500x magnification, nital etching

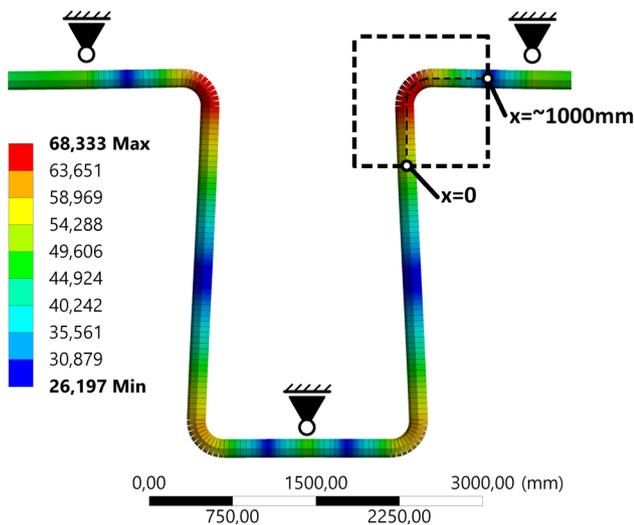
The example of the stress distribution in K2 compensator for environmental temperature and pipe outer surface temperature equal to -20°C is shown in Fig. 17. This stress results from the normal stress coming from bending and tension/compression. The figure shows its maximum value in a given location along pipeline axis. In each of the compensators, the stress distribution is very similar as in Fig. 17. The highest values can be observed in bends located by the main pipeline. Calculated specific values are, however, varied and dependent on which of the three pipeline segments given compensator is located.

Fig. 17. Equivalent stress [MPa] distribution in the K2 compensator for the environmental temperature and pipe outer surface temperature both equal to -20°C . Intermediate supports locations are showed. Visible deformation is scaled. Dashed rectangle shows pipeline part from Fig. 20

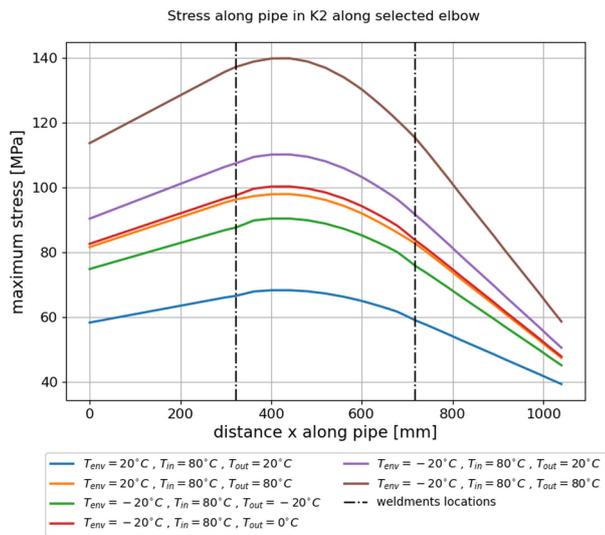
The stress distribution in the vicinity of a single bend of the compensator K2 (Fig. 2) is showed in Fig. 20. The stress is plotted as a function of the pipe length measured along its route. Maximum stress occurs within the bend, but a bit further from it, in both directions, where the actual welded joints are located, the stress is significant lower. More sharp decline appears in case of the part located on the main pipeline route, which is caused by a close proximity of the pipe support. Therefore, actual value of the stress in the place where welded joints are located should be even lower that it was initially estimated in Fig. 18 and 19.

Fig. 20. Maximal stress [MPa] distribution along pipeline in the part depicted in Fig. 17 for selected cases of temperatures. Dash-dotted lines show actual location of welded joints connecting bend with the straight pipes.
