Kapoor K, Muthusamy E, Goyal D, Pattathu G N, Study on Reliability of Field-Aged Photovoltaic Connectors, *Eksploracja i Niezawodność – Maintenance and Reliability* 2025: 27(3) <http://doi.org/10.17531/ein/199496>

Study on Reliability of Field-Aged Photovoltaic Connectors

Kartik Kapoor^{a,*}, Eswaramoorthy Muthusamy^a, Devendra Goyal^b, Nikhil Pattathu G^c

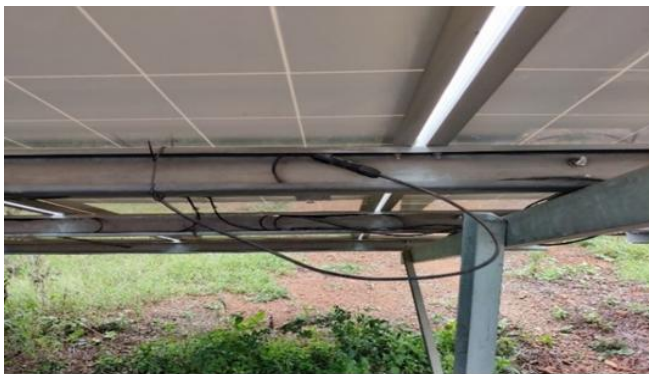
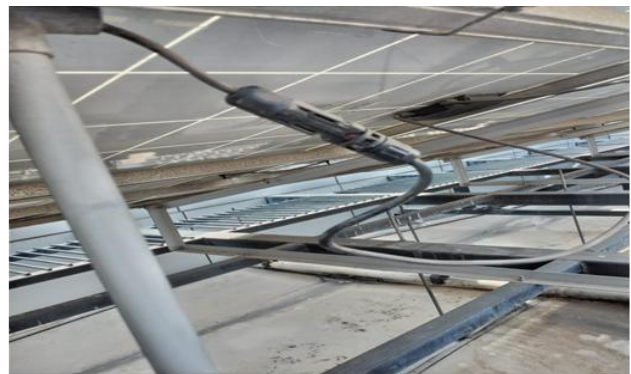
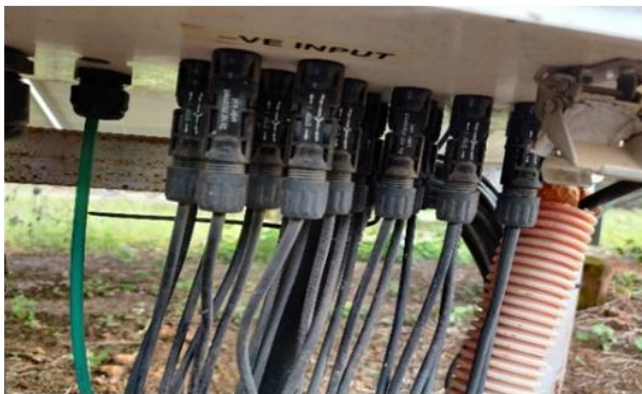
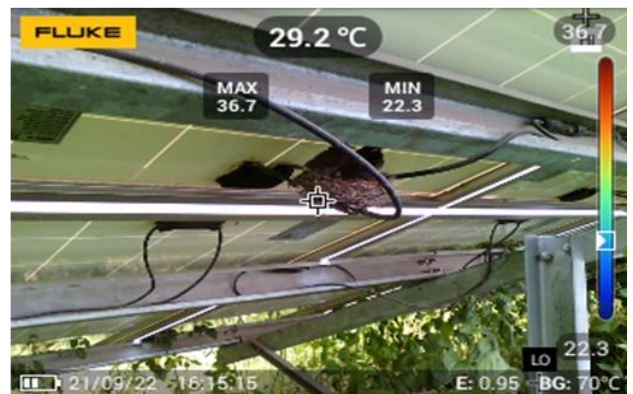
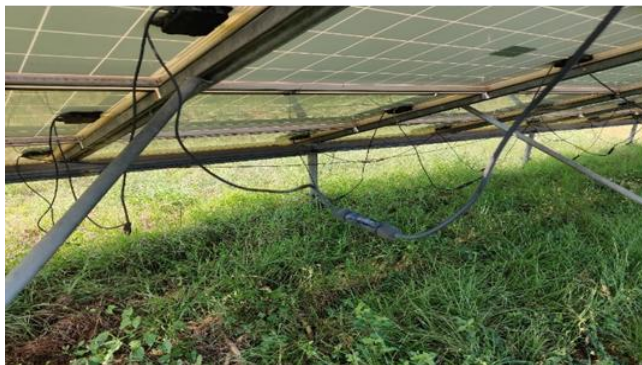
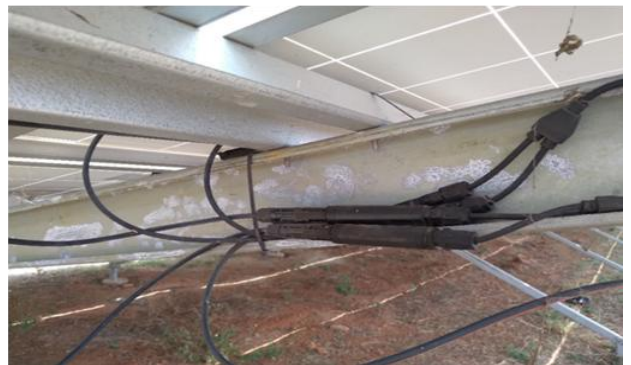
During the site visit, it was seen that there was stress in the connectors as a result of wires and connectors dangling from the module mounting structure in certain plants. A few of the connections between the string and SCB are not tightly sealed, making them vulnerable to the infiltration of dust and moisture. The majority of sites exhibit inadequate wire and connector

discipline which causes mechanical stress in a connector at a later stage due to incorrect bending. This is more prevalent

during the operation and maintenance phase due to bad workmanship rather than installation as depicted in Figure 5.

Figure 5. (a) Hanging connectors on the Module Mounting Structure at Deogarh (b) Bend and hanging connectors at Delhi rooftop plant site (c) Photovoltaic plug connectors loosely tightened in SCB at Pune plant site (d) Birds' nest with hanging connectors and on Module Mounting Structure at Pune plant site (e) Wires with connectors hanging at Dehradun plant site (f) Bundled-up connectors at Chennai plant site.

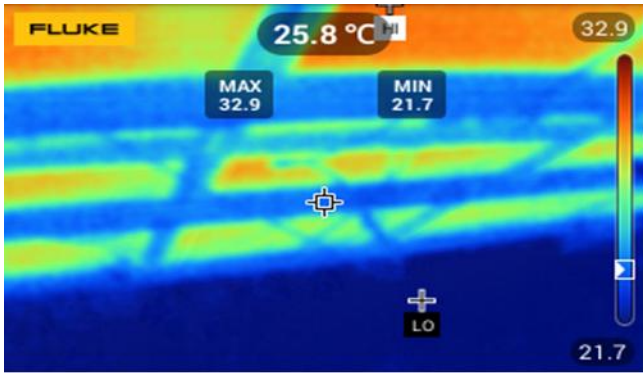
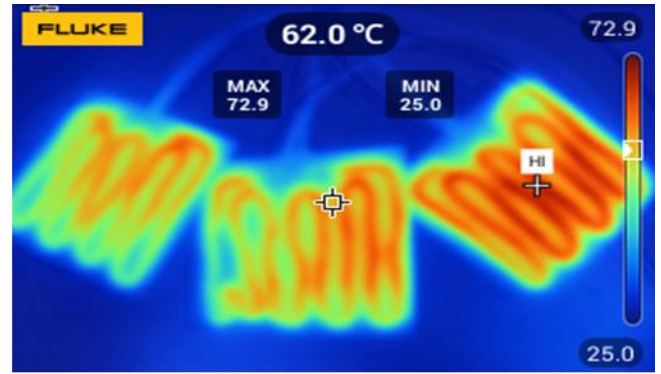
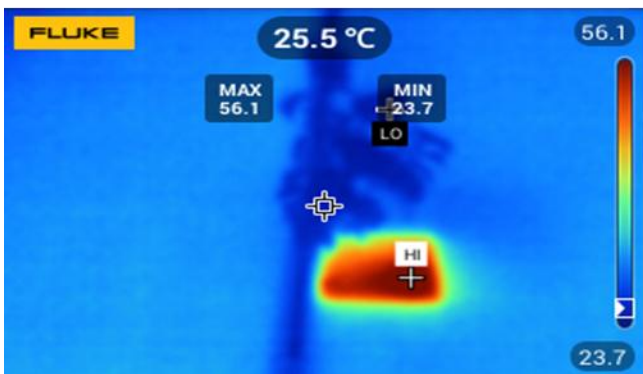
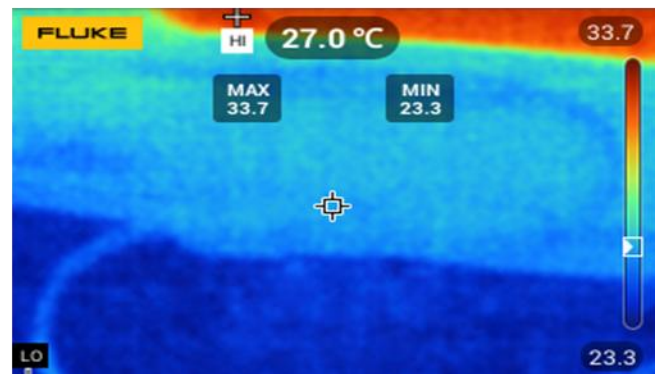
Thermal imaging revealed that several PV connectors had temperature increase of more than 20°C over ambient temperature, which could cause further heating and system malfunction. These strings of PV plug connectors were quite dirty and had hotspots. The hotspots are also visible on the

connectors which were bunched together in the Rajasthan site as shown in Figure 6 (b). Figure 6 (c) below illustrates that the solar cell in the module had also developed hotspots which had hotspots on connectors. If such connectors are not maintained in a routine manner, under severe circumstances they may burn, harming the module, or, in the worst case, result in a fire inside in the plant.

Figure 6. (a) Thermal imaging showing connectors hanging on the MMS at Pune site (b) Connectors bunched up together showing hotspots at Jaisalmer site(c) Hotspots on solar cell of the module which had connectors at Jaisalmer site (d) Connectors fitted with module mounting structure in a correct way.

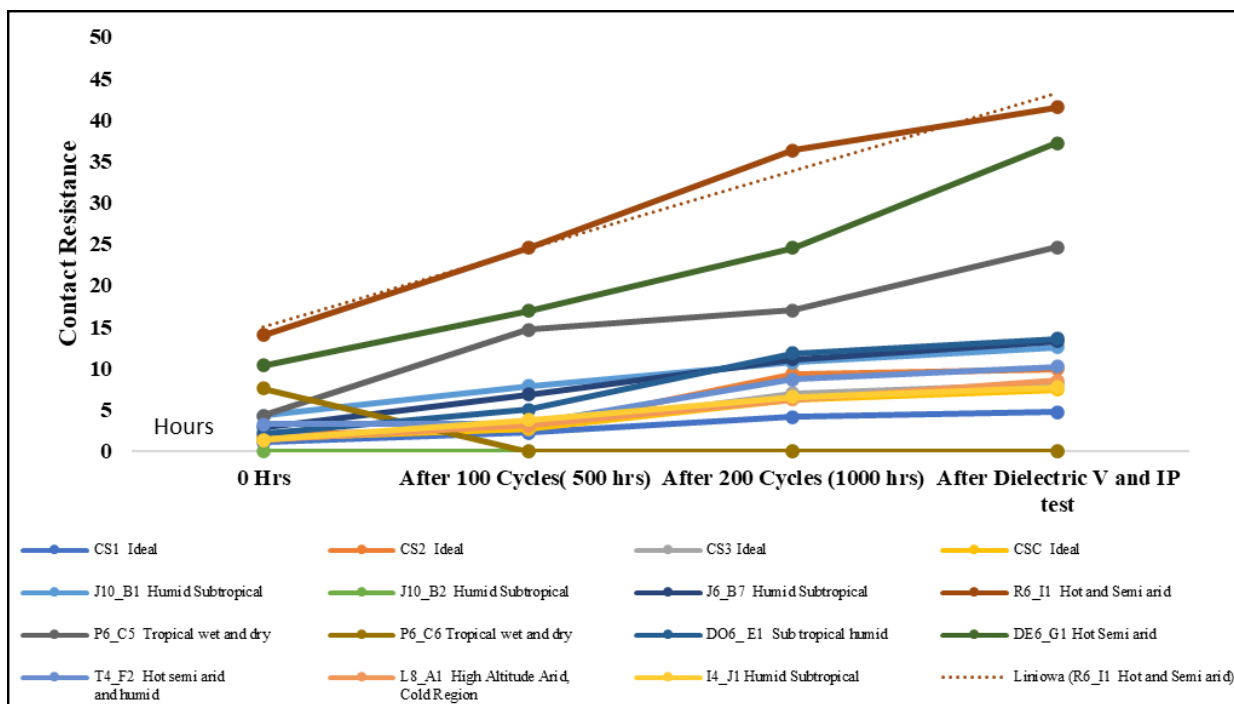
resistance values after 200 cycles of 1000 hours of thermal cycling test. The mean contact resistance at 0 hours is 3.94 mΩ, with a standard deviation of 3.82 mΩ. After 500 hours, the average contact resistance reaches 7.42 mΩ with 6.98 mΩ as its standard deviation. After 1000 hours, the average contact resistance increases to 12.29 mΩ with 9.02 mΩ as its standard deviation. The average contact resistance rises to 15.34 mΩ with 11.74 mΩ as its standard deviation after carrying out the dielectric voltage and IP test.

Figure 9. Values of contact resistance of 12 connectors depicted during Thermal Cycle testing of 1000 hours.

All connectors passed the dielectric voltage withstand test after undergoing a full cycle of testing except the connector from Rajasthan, Jaipur (R6_J1) with six years of operational life which failed in all subsequent tests of IP and glow wire. It has

initially, their values increased non-linearly throughout the testing and showed a sharp increase with highest being for the connector from Rajasthan (R6_J1) with 6 years of operation life that measured 41.5 mΩ with degradation of almost 300% of the initial value. Different samples exhibited varying rates of increase in contact resistance which implies that some connectors may be more prone to changes over time than others. Contact resistance is further increased in connectors from hot semi-arid and tropical wet and dry regions after the dielectric voltage and IP test indicating that the connectors experienced further stress or degradation.

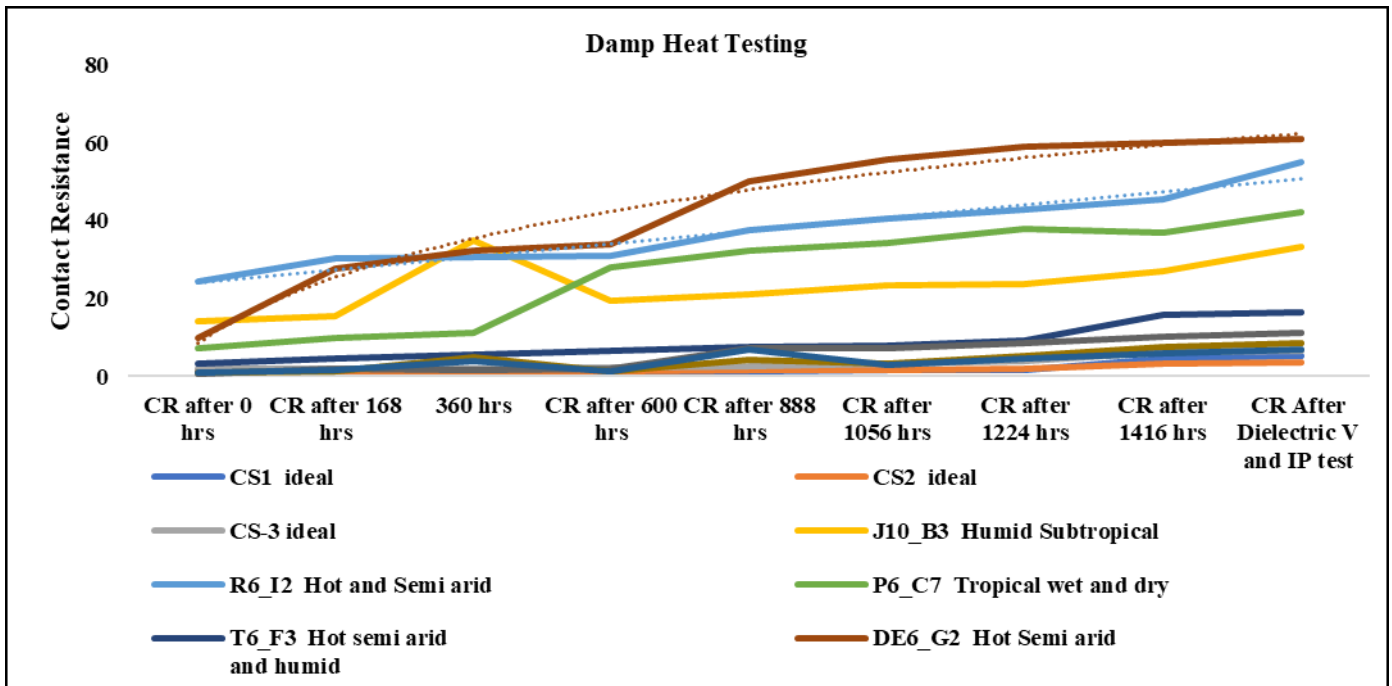
connectors passed the dielectric voltage withstand test however, insulation resistance for the connector from Jharkhand (J10_B3) (sub-tropical humid) failed with 10 years of operational life. All connectors passed the subsequent testing of IP, and glow wire except the connector from Delhi (Hot Semi-arid climate) with six years of operational life which failed in all parameters with a degradation of 600% from its initial value.

Despite passing the dielectric voltage withstand test, IP test, and glow wire test, it should be noted that the connector has failed or is almost failing at a contact resistance of 200% of the initial value. This indicates that the failure of the connector is unrelated to the results of IP and glow wire tests; nevertheless, the opposite is also true.

Figure 11. Values of contact resistance of 11 connectors depicted during Damp Heat testing for 1416 hours.

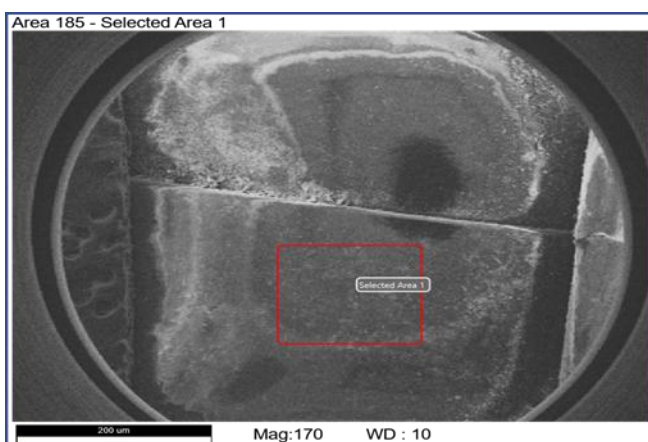
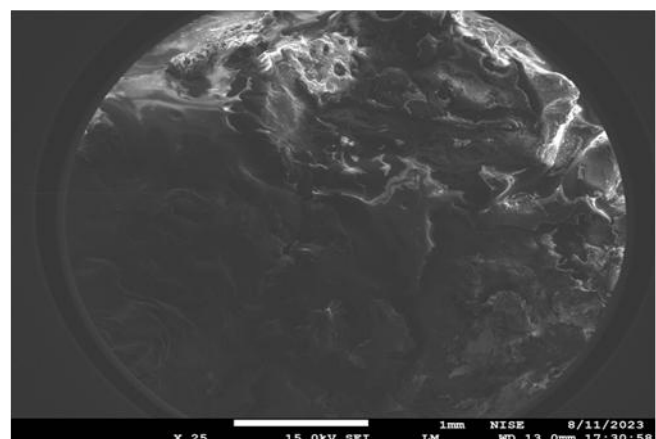
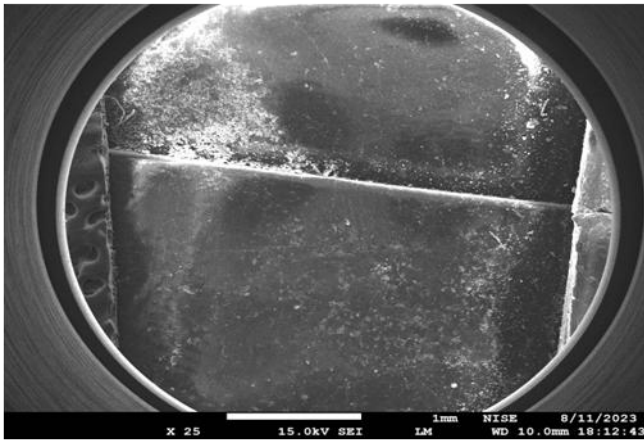
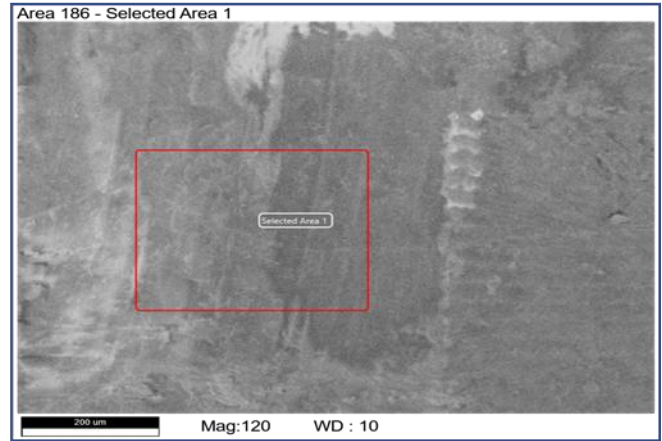
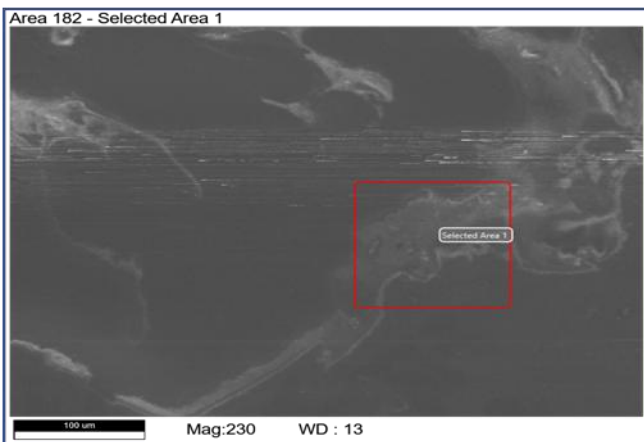
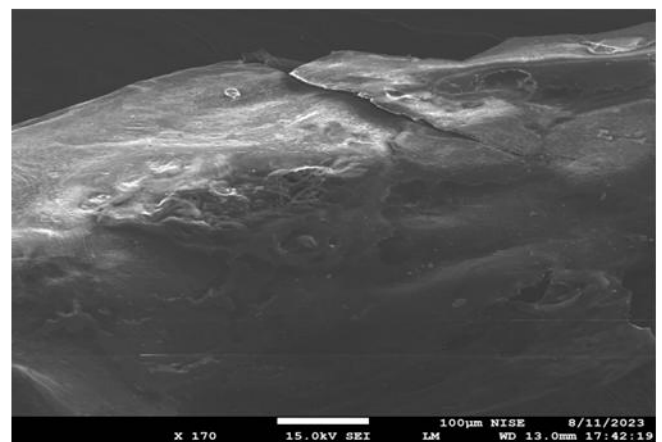
It was noticed during the SEM analysis that the connectors from Leh (High altitude arid, cold region) and Rajasthan (Hot and semi-arid, desert) had polymer material deterioration in the outer insulation casing of the connector as visible in the SEM images Figure 14 (d) (e), and (f). The possible reasons can be due to the extreme climatic conditions and temperature variations in these regions during summer and winter and high intensity of ultraviolet rays in Leh. The next concern that was noticed was the presence of fretting on the metal pins of connectors which had shown high values of contact resistance initially as visible in Figure 14(a) and (c).

Figure 14. (a), (b) and (c) SEM analysis showing the dust and corrosion inside the connector interior surface (d), (e) and (f) SEM analysis showing fragmentation of material on the outer surface of a connector.
