Piotr SOKOLSKI  
Marek SOKOLSKI

## EVALUATION OF RESISTANCE TO CATASTROPHIC FAILURES OF LARGE-SIZE CATERPILLAR CHAIN LINKS OF OPEN-PIT MINING MACHINERY

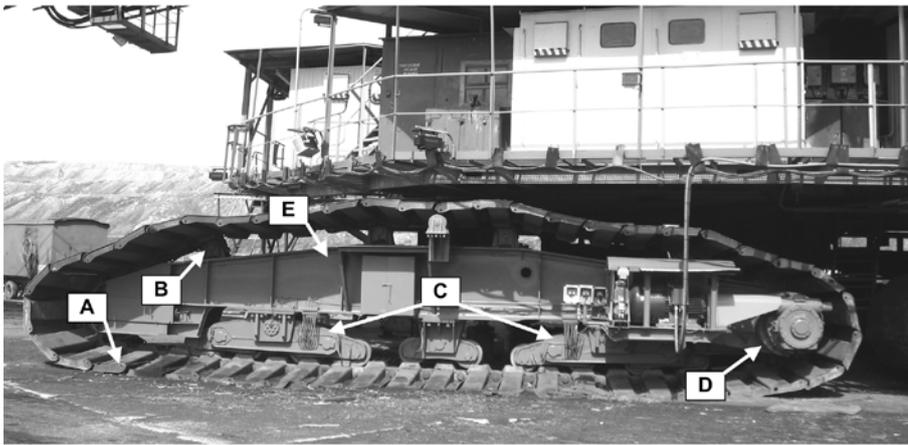
Fig. 1. Basic subassemblies of a large-size tracked undercarriage: A – caterpillar chain, B – supporting wheels, C – balance lever's units, D – driving wheel, E – caterpillar's girder [authors' archive]

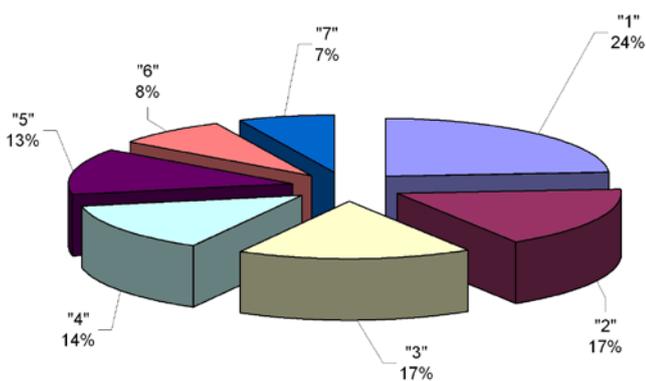
Fig. 2. The structure of failures of caterpillar undercarriages of basic machines in Polish open-pit mines: 1 – unit of upper supporting wheel, 2 – unit of balance lever and carriage, 3 – girder's supporting structure, 4 – caterpillar chain, 5 – unit of driving wheel, 6 – unit of turning wheel, 7 – drive of the caterpillar [12]

Statistics show that damages of caterpillar chains account for about 15% of all cases of damages of the driving units of multi-bucket excavators (Fig. 2) [12]. Nearly 70% of them arise from operational reasons: due to high dynamic loads (especially during start-up and turning), severe tribological conditions in the chain (limited ability to provide adequate lubrication, which results in faster abrasive wear

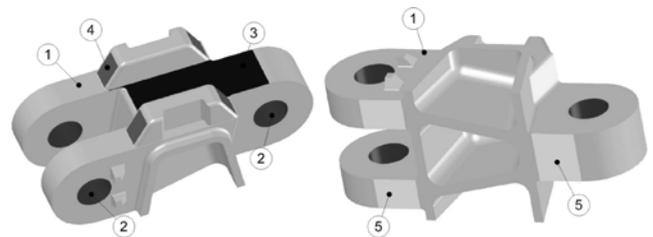
Fig. 3. Areas of basic degradation of large-size chain links [12] (detailed description in the text)

The research shows that the degradation of chain links occurs primarily in the following areas (Fig. 3) [12]:

- In the area of lugs (zone „1”, Figure 3). The degradation in these areas is an effect of extremely high workloads, unexpected in the normal operation. Such situations may occur for example during a turning process with a curve radius too small, especially in case of turning in place. It can result in a plastic deformation or a fracture of lugs and each of these cases is virtually irreparable damage, rated as a so-called catastrophic one.

- At the surfaces of holes in the pin joints in the links' lugs (zone “2”, Figure 3). This degradation is an abrasive one and is caused by friction between the pins and bushings with corrosion and mechanical impurities inside the joints.

- At the surface of the raceway of the links (zone “3”, Figure 3). This degradation is an effect of rolling out of the upper part of the link by rolling wheels. In addition, impact loading may appear when rolling wheels overrun subsequent links.

- At the front and rear of the upper parts of the links in the contact area with driving wheel (zone “4”, Figure 3). The degradation of these areas is a result of the impact of driving system's teeth. Due to the necessity of the combine forward or back-

- At the base of the link's lugs (zone “5”, Figure 3). Degradation in this area is caused by friction between subsoil and links under the action of large loads (unit pressure of 100 kPa).

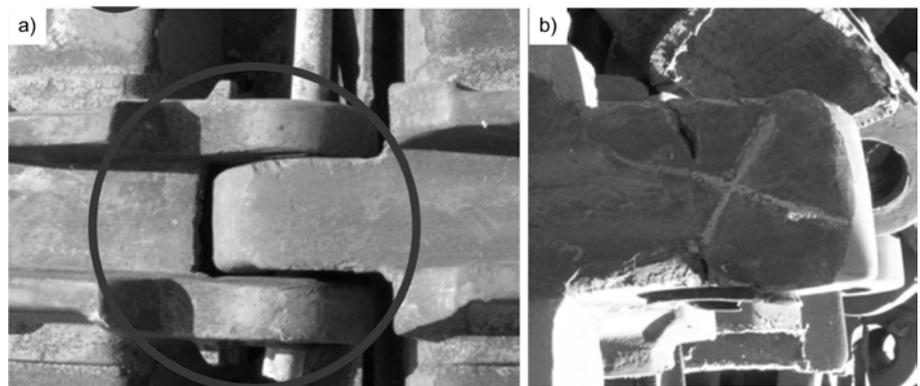
Fig. 4. Examples of failures of links' lugs: a) plastic deformation, b) brittle fracture [authors' archive]

Small plastic deformation of links' lugs does not always mean a need for instant exchange of the link, but continued usage of such a part could result in damage to other parts of the driving unit.

A typical example of the negative consequences of continued use of links and connecting pins with plastic deformations is a phenomenon called bevelling of crawler treads which causes an uneven distribution of loading on the subsoil. In extreme cases, this can lead to damage to the crawler treads by their mutual overlap.

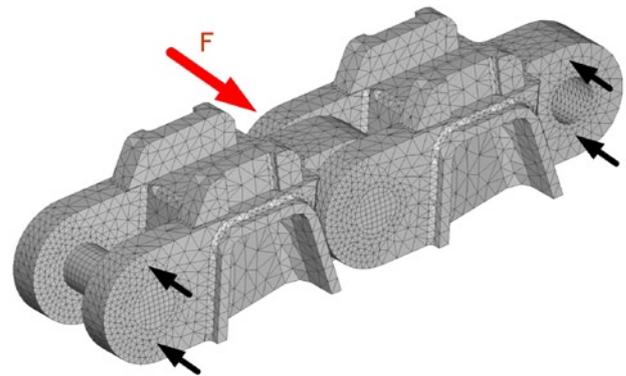
Fig. 5. Discrete model of "link – pin – link" connection [12]

In view of the possible consequences of lugs' damage, the authors have developed basic numerical models of large-size links used in excavators' and stacker's undercarriages. One such a model of links type "I" is shown in Figure 5.

Strength analyses were carried out using finite elements method for lateral loads in the range of  $F = 10 \div 10,000$  kN, assuming some specific boundary conditions (support of links' connection). In the calculations the strength and ductile properties of cast steel L35GSM (Yield strength  $R_e = 850$  MPa among others) as the material from which the links are made were taken into account. As the main objectives of the numerical simulations the following were assumed:

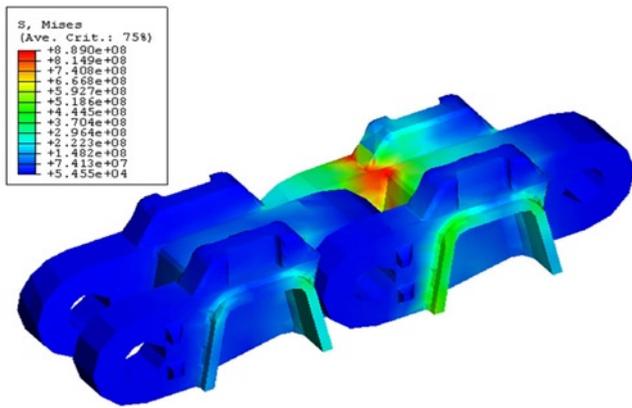
Fig. 6. Exemplary distribution of von Mises stress in the “link – pin – link” connection under the influence of plasticizing lateral loading.

Basing on results of the calculations it was found out that one of the most dangerous areas in the "link – pin – link" connection zone are bases of the narrow lugs. It was also shown that the limit value of lateral load which surpassing results in plasticizing of the links type "I" is about  $F_{max} \approx 3000$  kN. Exemplary results of stress analysis for such values of load are shown in Figure 6.

On the basis of the standard PN-G-47000-2: 2005: "Open pit mining. Multi-bucket excavators and stackers. Part 2: Introduction to computing" it was assumed that the required safety factor of links related to the yield stress is  $X = 1,3$ . This means that the maximum value of the stress in the links, as defined by Huber – von Mises yield criterion should not exceed 650 MPa.

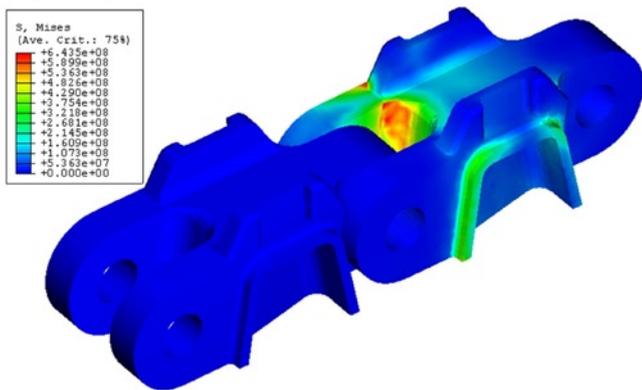
Fig. 7. Exemplary distribution of von Mises stress in the “link – pin – link” connection under the influence of plasticizing lateral loading after applying modifications of the critical areas.

With this in mind, concepts of geometrical modification of the links in their critical areas were developed. It is where the material’s plasticization occurred. In particular, changes were introduced in the areas of bases of both the narrow and the broad lugs. Modifications included as well surfaces of the links mating with the driving wheel. These modifications are described in detail in [12]. The results of the simulation of effort of links with modified geometry are shown in Figure 7.

It is noticeable that after the changes in the geometry of the critical sections, as proposed by one of the authors [11, 12], a significant reduction in the maximum values of von Mises stress is achieved (up to the level of 650 MPa).

This also means that the modified chain links are able to carry the load capacity larger by about 30% when compared to currently used links. This can help to increase the safety and reliability of caterpillar undercarriages of basic machinery.
