# The local load-carrying capacity of composite structures undergoing bending under variable boundary conditions

Różyło P, Wysmulski P, The local load-carrying capacity of composite structures undergoing bending under variable boundary conditions, *Eksplotacja i Niezawodność – Maintenance and Reliability* 2027; 29(1) <https://doi.org/10.17531/ein/225077>

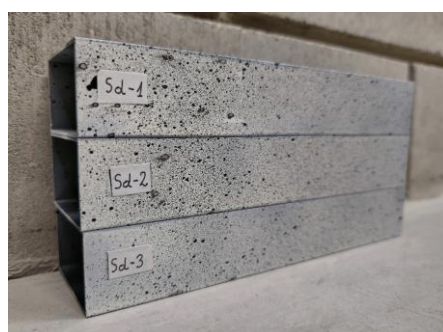
Figure 1. Test specimens.

The composite specimens consisted of eight layers of composite material of equal thickness, giving the composite profile walls a total thickness of 1.24 mm. The cross-section of the composite profile was 50x30 mm. The composite profile was 200 mm long. The composite lay-up was  $[90^\circ/-45^\circ/45^\circ/0^\circ]_s$ . Six composite columns were used in the study. Specimens supported on the wider surfaces of the profile (Sd-1, Sd-2 and Sd-3) are shown in Fig. 1a, while specimens supported on the narrower surfaces (Sd-1x, Sd-2x and Sd-3x) are shown in Fig. 1b. The only difference between the specimens in Figs. 1a and 1b is that the profiles have been rotated by  $90^\circ$  for the purposes of the research described in the research methodology section. All samples have identical dimensions.

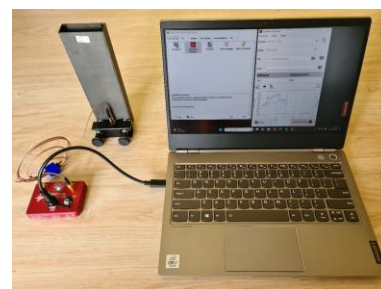
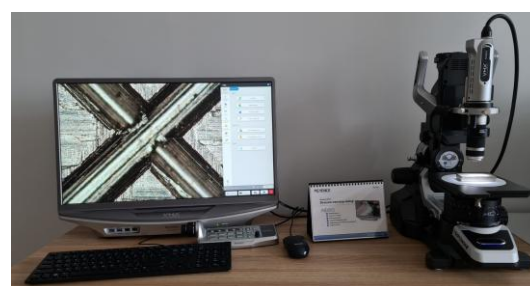
Figure 6. Additional measuring devices: (a) AE system, (b) 2D DIC system, (c) digital microscope.

the crosshead displacement of the UTM and was registered using the Amis Plus system, which is compatible with the UTM. Furthermore, non-destructive testing equipment for composite materials was used as part of the research activities. This type of equipment enables additional quantitative and qualitative assessment of the structure's behaviour in static tests. For quantitative assessment, a SpotWave 201 single-channel acoustic emission (AE) system (Vallen Company) was used. This device enabled acoustic signals to be registered (based on the registration of elastic waves in the material), facilitating the evaluation of composite material damage during three-point bending. The VS150-L passive piezoelectric sensor was used to register signals. This sensor is dedicated to testing thin-walled composite structures and aluminium alloys (materials with no ferromagnetic surface), among other things. Both the recording of acoustic signals and the subsequent analysis of the test results were performed using Vallen's dedicated AE software (Vallen Control Panel). Acoustic emission tests were carried out by attaching an acoustic emission sensor to the flat surface of the structure to which it must be permanently connected. During the tests, the energy signal, number of counts and amplitude were primarily measured. The Aramis device for digital image correlation in the basic 2D version was used more for qualitative evaluation of the three-point bending phenomenon. Digital image correlation (DIC) is a procedure used to calculate 2D or 3D coordinates from single images or sequences of images captured using a single camera, a stereo camera, or a multi-camera system. Using a non-contact deformation measurement system makes it possible to measure deformation levels during bending processes and observe critical areas of the structure. DIC enables displacements and deformations to be measured in real time and the deformation process analysed, including the observation of crack propagation, delamination and damage to various materials and structures. In the study, the digital microscope VHX-970F (VHX-7000 series from Keyence Company) was used to assess the structural damage to the material, mainly in a qualitative context. This microscope enabled a qualitative assessment of the damage zone using the depth composition function. This enabled both precise registration of superficial damage to the material structure and registration of the complex nature of damage through the depth of focus of areas slightly distanced from each other. In this study,

a VH-Z20T zoom lens with a maximum magnification of 200x was used as the recording head (camera); however, the magnification used during the study was much lower, which was sufficient to visualise the recorded damage. Further information on the digital microscope used in this study can be found in scientific publications on the stability and load-carrying capacity of compressed thin-walled composite profiles [23,30]. Additional measuring devices are shown in Fig. 6.
