# The local load-carrying capacity of composite structures undergoing bending under variable boundary conditions

Różyło P, Wysmulski P, The local load-carrying capacity of composite structures undergoing bending under variable boundary conditions, *Eksploracja i Niezawodność – Maintenance and Reliability* 2027; 29(1) <http://doi.org/10.17531/ein/225077>

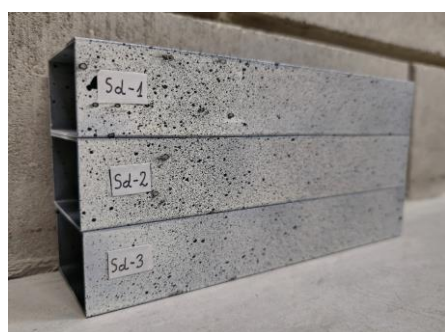
Figure 1. Test specimens.

The composite specimens consisted of eight layers of composite material of equal thickness, giving the composite profile walls a total thickness of 1.24 mm. The cross-section of the composite profile was 50x30 mm. The composite profile was 200 mm long. The composite lay-up was  $[90^\circ/-45^\circ/45^\circ/0^\circ]_s$ . Six composite columns were used in the study. Specimens supported on the wider surfaces of the profile (Sd-1, Sd-2 and Sd-3) are shown in Fig. 1a, while specimens supported on the narrower surfaces (Sd-1x, Sd-2x and Sd-3x) are shown in Fig. 1b. The only difference between the specimens in Figs. 1a and 1b is that the profiles have been rotated by  $90^\circ$  for the purposes of the research described in the research methodology section. All samples have identical dimensions.

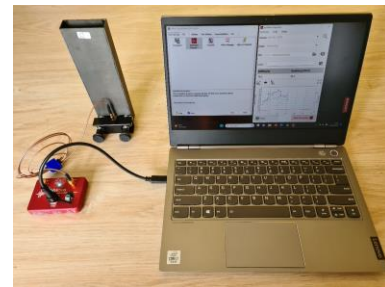
Figure 6. Additional measuring devices: (a) AE system, (b) 2D DIC system, (c) digital microscope.

the crosshead displacement of the UTM and was registered using the Amis Plus system, which is compatible with the UTM. Furthermore, non-destructive testing equipment for composite materials was used as part of the research activities. This type of equipment enables additional quantitative and qualitative assessment of the structure's behaviour in static tests. For quantitative assessment, a SpotWave 201 single-channel acoustic emission (AE) system (Vallen Company) was used. This device enabled acoustic signals to be registered (based on the registration of elastic waves in the material), facilitating the evaluation of composite material damage during three-point bending. The VS150-L passive piezoelectric sensor was used to register signals. This sensor is dedicated to testing thin-walled composite structures and aluminium alloys (materials with no ferromagnetic surface), among other things. Both the recording of acoustic signals and the subsequent analysis of the test results were performed using Vallen's dedicated AE software (Vallen Control Panel). Acoustic emission tests were carried out by attaching an acoustic emission sensor to the flat surface of the structure to which it must be permanently connected. During the tests, the energy signal, number of counts and amplitude were primarily measured. The Aramis device for digital image correlation in the basic 2D version was used more for qualitative evaluation of the three-point bending phenomenon. Digital image correlation (DIC) is a procedure used to calculate 2D or 3D coordinates from single images or sequences of images captured using a single camera, a stereo camera, or a multi-camera system. Using a non-contact deformation measurement system makes it possible to measure deformation levels during bending processes and observe critical areas of the structure. DIC enables displacements and deformations to be measured in real time and the deformation process analysed, including the observation of crack propagation, delamination and damage to various materials and structures. In the study, the digital microscope VHX-970F (VHX-7000 series from Keyence Company) was used to assess the structural damage to the material, mainly in a qualitative context. This microscope enabled a qualitative assessment of the damage zone using the depth composition function. This enabled both precise registration of superficial damage to the material structure and registration of the complex nature of damage through the depth of focus of areas slightly distanced from each other. In this study,

a VH-Z20T zoom lens with a maximum magnification of 200x was used as the recording head (camera); however, the magnification used during the study was much lower, which was sufficient to visualise the recorded damage. Further information on the digital microscope used in this study can be found in scientific publications on the stability and load-carrying capacity of compressed thin-walled composite profiles [23,30]. Additional measuring devices are shown in Fig. 6.
