Safety and reliability assessment of personal electric kick-scooter riding with different tire types

Mykola Karpenko[a,*]

[a] Department of Mobile Machinery and Railway, Vilnius Gediminas Technical University, Lithuania

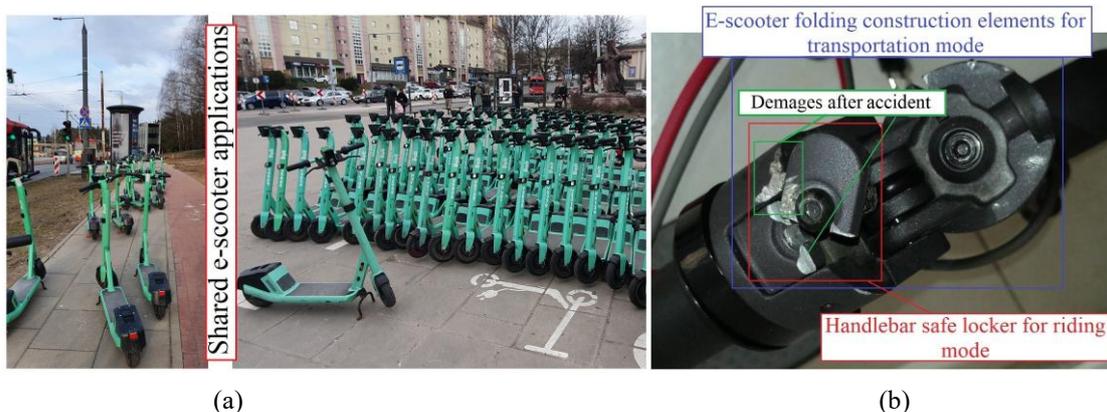
Figure 1. Electrical kick-scoter research introduction views: (a) Modern use of electric kick-scooters in shared applications on Vilnius (Lithuania) city case example; (b) Broken handlebar safety lock of electric kick-scooter after accident.

After accident, there was made a detail investigation to find what fact was led to risk factor, what is base for current research. First of all, problem comes after tire changes, in dynamic simulation of any vehicles, tire modelling plays a crucial role due to the tire being the sole component in contact with the ground, responsible for transmitting the necessary forces for motion and feedback from the road [11,12]. Secondary, the problems come after drive from asphalt sidewalk pavement on small brick type of pavement. The primary objective in the field of machine vibration impact analysis was to assess the correlation between vibration levels induced by motorways and the resulting of dynamic vibration to machine components operation. Notably, intriguing findings from experimental studies utilizing ambient vibration were highlighted in the paper [13]. In this context, determining the stiffness of the machine elements played a crucial role in evaluating the effects of recorded vibrations [14]. Conversely, paper [15] explored the impact of road surface roughness when heavy vehicles pass by, revealing that the characteristics of the road surface influence the propagation of vibration waves. This all mention above, well integrates and associated with micro-mobility vehicles dynamics. However, analysing of e-scooter components in real-time operations presents a challenge due to the widespread use of batch processing techniques. To enable real-time vibration analysis for its elements, a temporal approach must be integrated with the frequency technique using a method known as time-frequency representation [16]. The advantage of frequency-based methods is that they typically do not require parameter tuning, such as adaptive gains [17]. However, these methods inherently rely on batch processing, which necessitates vibration level measurements. They are widely employed for detecting and quantifying faults using vibration-based data [18]. Frequency domain characteristics, including frequencies, damping ratios, energy in different frequency ranges, and time-frequency domain characteristics like time-frequency spread [19], serve as key features for conducting structural health monitoring [20]. Notable techniques include linear non-parametric methods like the short-time Fourier transform, wavelet transform, or Wigner-Ville distribution [19,20]. Applying these methods involves a trade-off between vibration time and frequency response resolutions [21], yet they remain among the most effective methodologies for detecting and quantifying faults using vibration-based data.

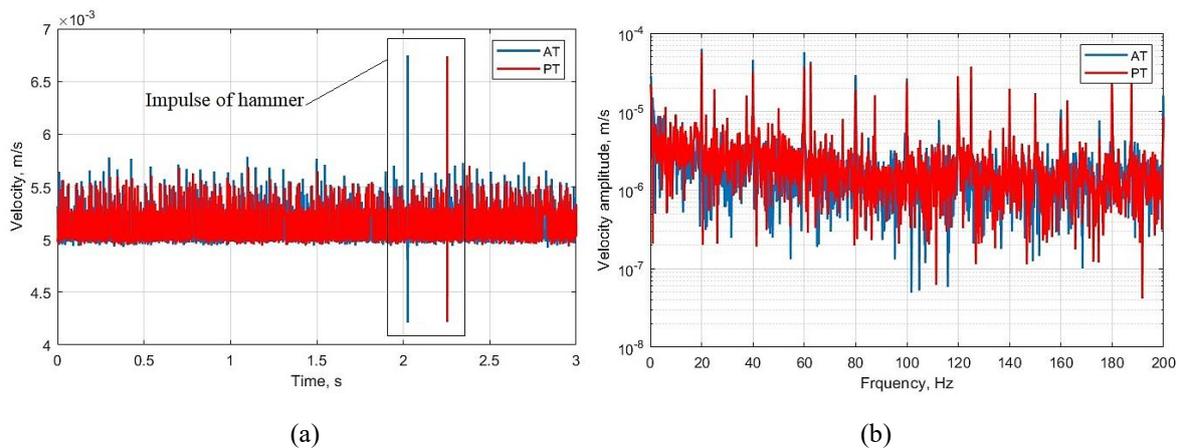
Figure 5. Results from tires modal analysis (AT – airless tire; PT – pneumatic tire): (a) Tires vibration velocity by laser scanning; (b) Frequency response of tires under modal analysis.

The impulse value of hammer for both tires its similar, the different not more than 2% (Fig. 5a), more or less the different in the time of action not influence on frequency transformation in modal analysis. Moreover, the primary focus of the conducted model analysis lies within the frequency range of up to 200 Hz, as illustrated in Fig. 5b. This specific frequency range captures the essential resonant modes under investigation. Furthermore, the frequency analysis reveals that the main resonance

frequency for both tires is found at 20 Hz, and interestingly, the first resonance frequency also occurs at the same value of 20 Hz. Moreover, harmonics are observed at regular intervals, precisely at every 20 Hz (20/40…etc. Hz). This outcome is quite logical, given that both tires are rubber-based objects. The consistent harmonic pattern further supports the resonant behaviour of the rubber material.

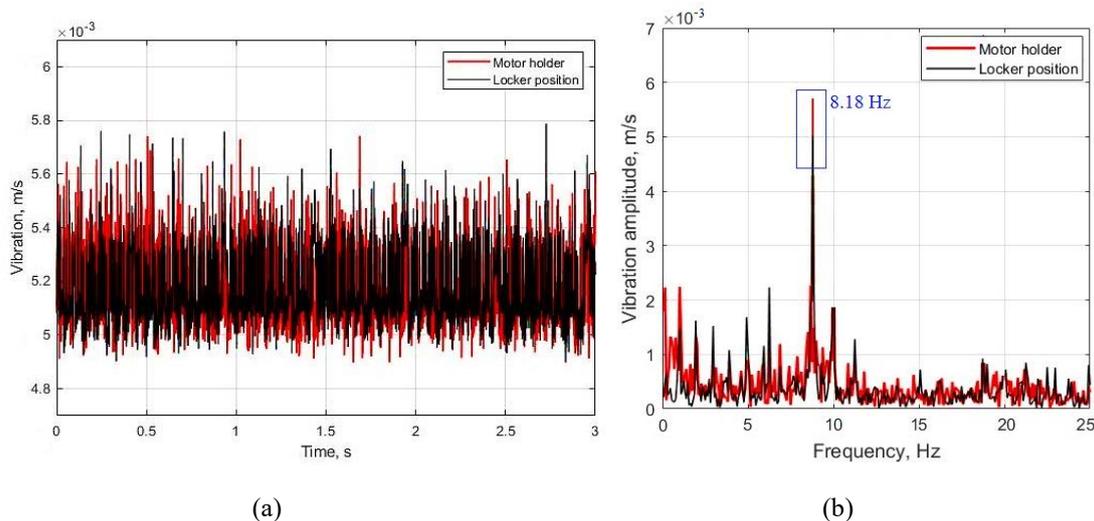
Figure 6. Results from e-scooter vibration transformation analysis: (a) Velocity vibration at e-scooter elements; (b) Frequency response at vibration transformation analysis.

The maximum vibration level produced by the in-wheel motor for the e-scooter at a speed of 20 km/h was recorded at the motor-wheel holder and measured to be approximately 5.78×10^{-3} m/s, and at the locker position, the maximum vibration was approximately 5.61×10^{-3} m/s (refer to Fig. 6a). Upon analysing the measurements, it appears that, for most of the registered vibration range, the difference between the two measurement positions is not significant. By studying the frequency response, it is evident that all vibrations from the motor-wheel holder are directly transmitted to the handlebar safety locker position with a slight dampening effect of up to 9% during observed frequency points (Fig. 6b). The analysis revealed a resonance frequency of 8.18 Hz during operation at 20 km/h (491 rpm). This finding confirms that the recorded vibrations are transmitted accurately and are dependent solely upon the mechanical conditions of the hub-motor system.

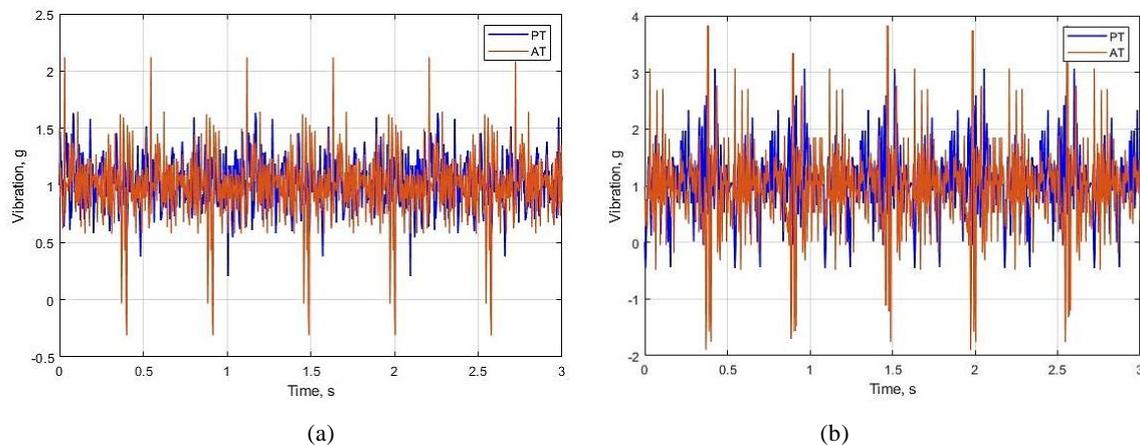
Figure 8. Vibration near handlebar safety locker riding on: (a) Asphalt cycle road pavement; (b) Bricks cycle road pavement.

When observing the measured vibration results (Fig. 8), it should be noted that the sensors were recorded with a standard calibration for vertical vibration at g ($g = 1$ – zero-base overview point). The 3-second time waveform shown in Fig. 8 was intended only as a visual representative sample to illustrate the raw signal characteristics and the data acquisition interface. The maximum level of vibration generated by the e-scooter while riding with a different tire type on the different types of surfaces during the test at a speed of 25 km/h was on the brick's pavement with AT tire types (at this condition was accidents before). At the same time, it is worth noting that the registered vibration level between the in-wheel holder and the locker position sensors did not exceed approximately 10% (see the pre-experimental part). This confirms that the vibrations experienced by the locker are predominantly influenced by the tire with pavement contact dynamics and that all measured vibrations were correctly detected. The measurements showed

maximum vibration levels of approximately 1.62g for PT (mean value 1.28g) and 2.23g for AT (mean value 1.63g) when riding on asphalt pavement. On brick pavement, the maximum vibration levels increased to 3.1g for PT (mean value 2.29g) and 3.89g for AT (mean value 2.87g). The analysis indicates significant differences in the vibration levels transmitted to the locker when riding with different tire types on different pavement surfaces. Vibrations induced by e-scooter motion on brick pavements have a pronounced impact on e-scooter components, particularly when using the AT tire type.
