Michnej M, Młynarski S, Pilch R, Sikora W, Smolnik M, Drożyner P. Physical and reliability aspects of high-pressure ammonia water pipeline failures. *Eksploracja i Niezawodność – Maintenance and Reliability* 2022; 24 (4): 728–737, <http://doi.org/10.17531/ein.2022.4.13>

Physical and reliability aspects of high-pressure ammonia water pipeline failures

Maciej Michnej^a, Stanisław Młynarski^a, Robert Pilch^b, Wojciech Sikora^b, Maksymilian Smolnik^b, Przemysław Drożyner^c

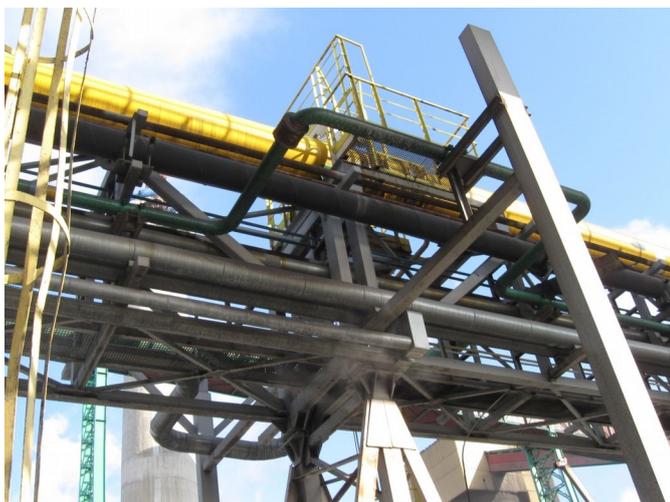
Fig. 1. View of a part of the ammonia water pipeline

After about two years of operation of the pipeline, liquid drops were observed in the area of thermal elongation compensators. The analysis of the condensate and the place of its appearance revealed the pipeline cracks and the leakage of the transported medium. The damages were found around characteristic points of the pipeline compensators. The formation of new cracks in the area of already existing damage was also observed. Due to the need for uninterrupted use of the pipeline, attempts were made to repair the pipeline in damaged places on an ad hoc basis by covering the leaky parts with additional tight external bands. The process of the failures occurrence was subjected to appropriate tests.

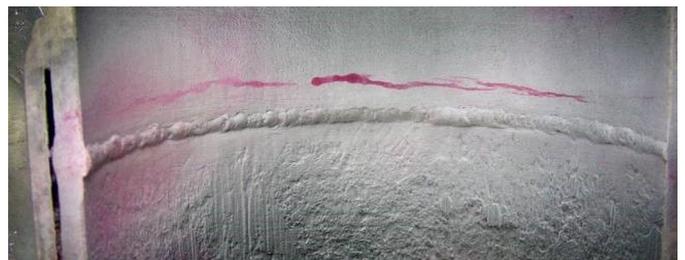
Fig. 10. Cross-sections of A1 (left) and C1 (right) welded joints

material of the pipeline in various places around the welded joints A1 and C1 are shown in Fig. 10. These cracks are located in the material outside the joint.

All the cracks in the pipeline near the joints were located in its bends and propagated from the inside of the pipeline. Where the crack reached the outer surface of the pipe, the medium penetrated the gap and the pipeline began to leak. Defects of joints visible in the cross-sections, such as shifts of the joined edges, may be of significant importance for the operation of the joint and the occurrence of the observed defects.

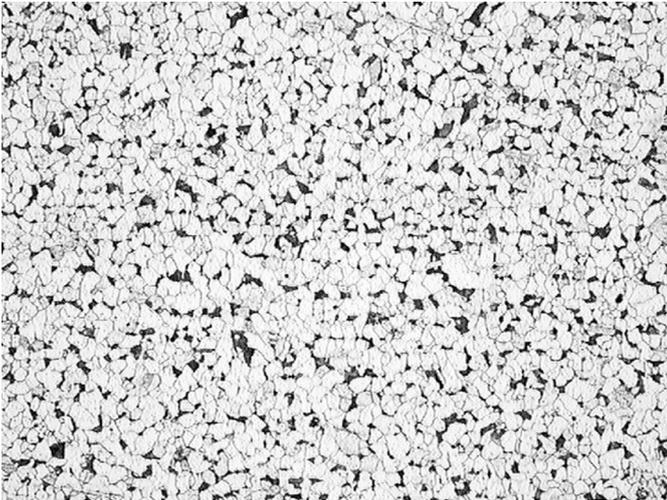
Fig. 12. Structure of the pipe material. 500x magnification, nital etching

The examination of the material structure of the pipeline elements was carried out on metallographic specimens obtained from parts of pipes and bends. The aim of the study was to identify the material from which the individual elements of the pipeline had been manufactured. The identification of the structure was necessary to further verify the causes of the failures. The structure of the pipe material is shown in Fig. 11 and 12 at magnifications of 100x and 500x. The observed structure was ferritic-pearlitic. The particles of perlite were lamellar. There were no irregularities in the examined structures in the form of inclusions or discontinuities.

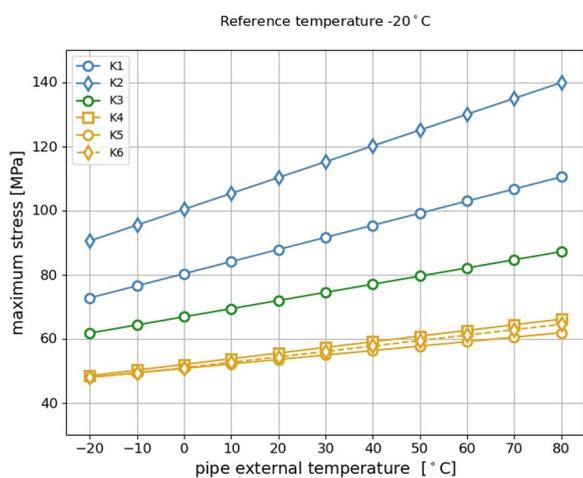
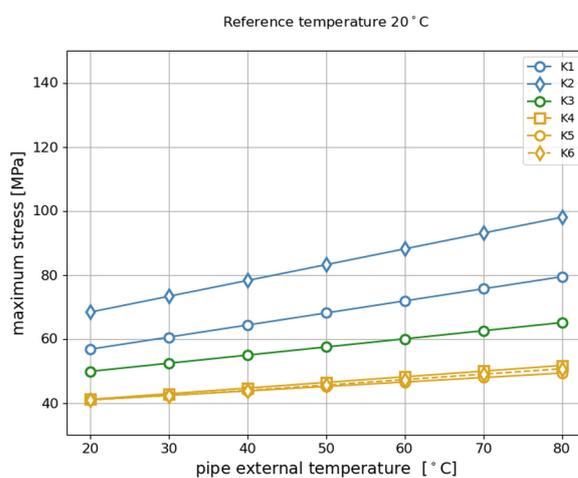
Fig. 18. Maximal equivalent stress [MPa] in pipeline compensators, as a function of pipe outer surface temperature for environmental temperature a) -20°C -20°C , b) 20°C

nal external pipe temperature can reach different values as it depends on the pipe surface emissivity and, also, environmental temperature. Therefore in the performed analysis a possible range of the pipe outer surface temperature was considered (Fig. 18 and 19) which allowed to obtain a potential range of stress occurring in the pipeline. Calculations were conducted for two different environment temperatures: +20°C and -20°C. Due to higher difference between the temperatures in the regard to a transported medium, higher mean stress was observed for the second variant.

Based on Fig. 18 and 19, which present the maximum values of stress in locations K and E as a function of temperature of the pipe outer surface, it can be observed that compensators K4-6 are loaded almost in the same way and stress level there is significantly lower compared to the rest of compensators. Next, according to the ascending load order, are compensators K3, K1 and K2. Higher value of stress in these pipeline parts can be explained through the lower number of compensators in the regard to the length of the given pipeline segment. In all these locations and for all temperature variants, maximum stress did not exceed yield stress for steel P235GH ($Re \approx 235 \text{ MPa}$)

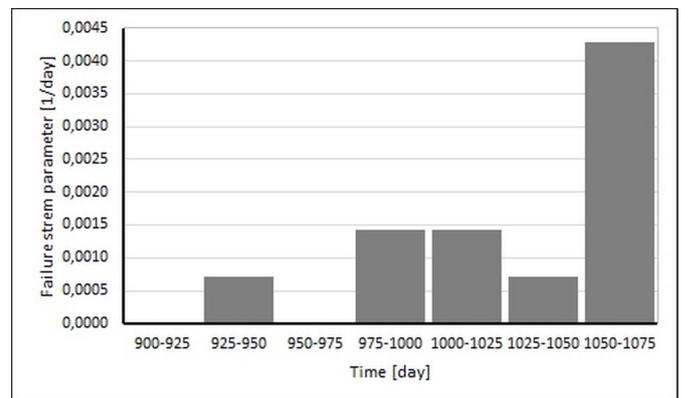
Fig. 21. Failure stream parameter values

The observation of its course shows that after the 925th day of operation, the value of the parameter becomes greater than zero and begins to increase. Generally, such a fact is interpreted as the time the technical object enters the aging period. In this case, the beginning of the increasing course over time can be interpreted as the beginning of the period in which the cracks initiated by corrosion and propagating from the inside of the pipeline, in some elements, already reach a length equal to the wall thickness and cause the failures observed as a pipeline leak. It can be assumed that in the further operation, the number of such failures will increase since the subsequent considered elements will most likely be damaged in the same way, and the observed values of failure stream parameter will continue to increase.

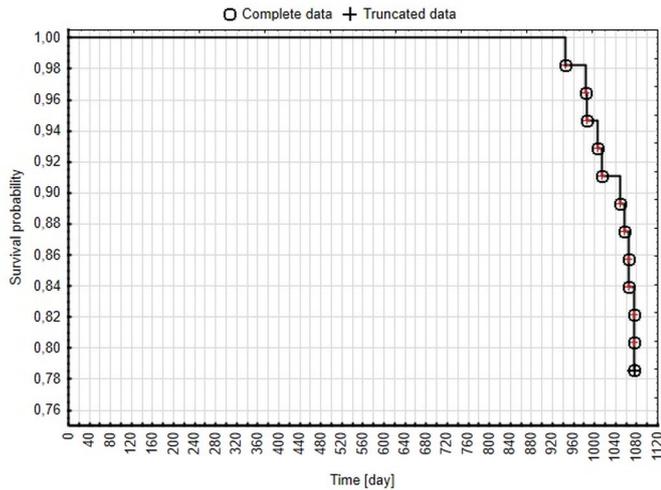
Fig. 22. Survival function for truncated data in the Kaplan-Meier analysis

The graph indicates the probability of surviving without a failure for a certain number of days for each individual element. This value drops very quickly after reaching the operating time of 940 [days]. It can be concluded that each of the remaining available (undamaged) components is less and less likely to survive the next days without a failure. As the probability decreases quickly, it is possible to predict the appearance of many successive failures in the observed set of elements over a short time.

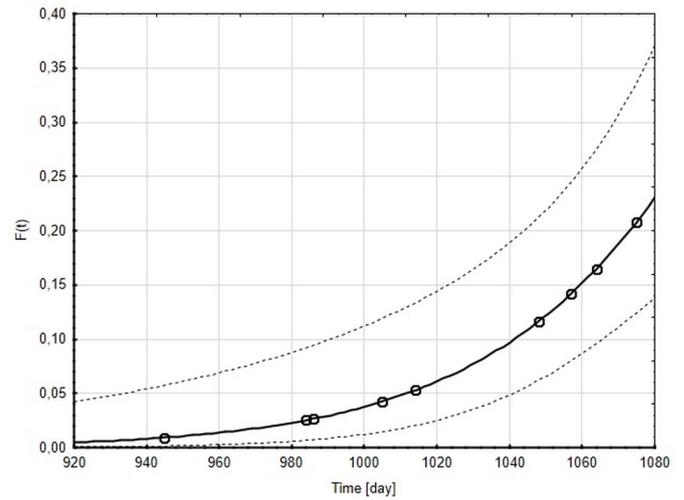
Fig. 23. Cumulative distribution function course for a single pipeline element with 95% confidence interval

The initial part of the cumulative distribution function $F(t)$ (for complete data) with the determined 95% confidence interval is presented in Fig. 23.

The determined changes in the values of the failure stream parameter, the survival function as well as the cumulative distribution function, the failure rate and the expected value of operation time till failure amounting to 1115 [days] allow one to suggest that in order to avoid subsequent failures of the pipeline, appropriate preventive

measures should be taken with regard to all available (undamaged) elements, as the probability of failure indicated by the indexes is high and increases rapidly over time. It should be borne in mind that the assumption adopted in the reliability analysis about the crack initiation and propagation in the welded joints areas does not actually have

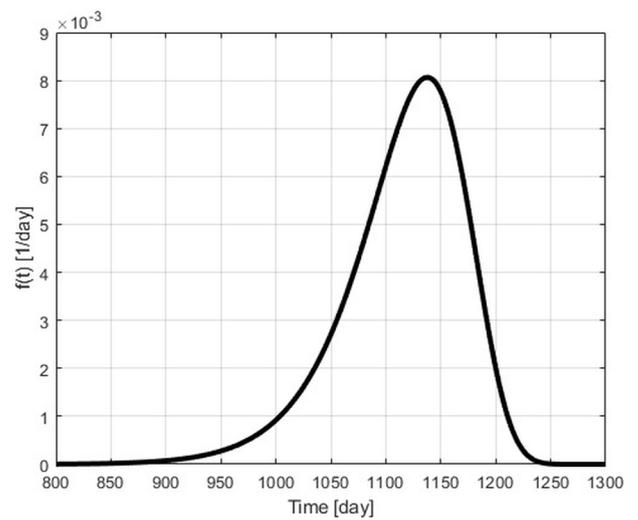
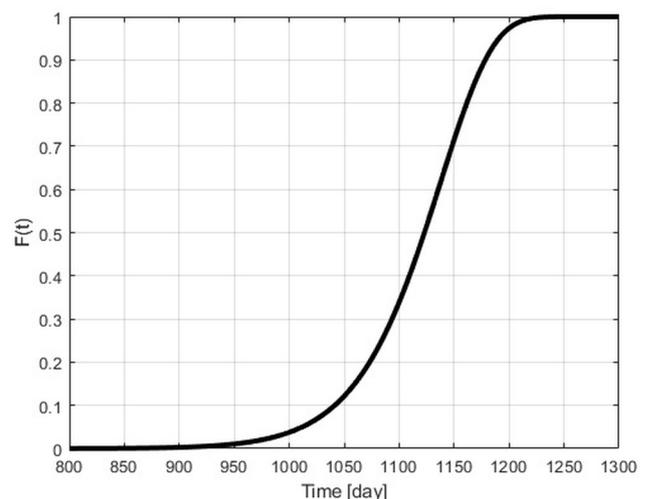
Fig. 24. Failure probability density function a) and cumulative distribution function of the operation time till failure b)

The graphs show an accumulation of the failure probability density between 1000 and 1200 operation days and a rapid increase in cumulative distribution function values during this time. The determined course of the failure rate shows its characteristic feature which is the intense increase over time. From this fact it can be directly concluded that the probability of failure of each element increases significantly with each subsequent period that it survives without a failure.

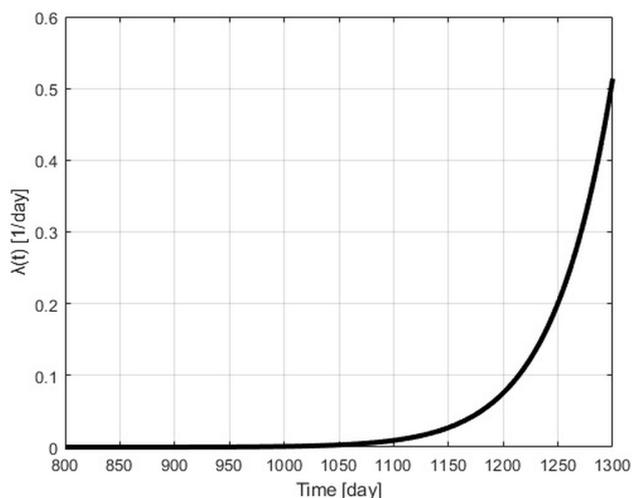
Fig. 25. Failure rate

to take place in each of them. However, due to: the method of making welded joints (without stress relief annealing), aggressive affecting of ammonia water on the pipeline material, high operating temperature and variable stresses, the appearance of a microcrack and its propagation from the inside to the outside of the wall is very likely and confirmed by observations in a number of objects of this type operated in very similar conditions [4, 9]. Hence, the suggested preventive measures in areas where leaks have not yet occurred seem to be the most justified, especially if the costs of carrying them out are lower than the later losses resulting from the failures.
