Kapoor K, Muthusamy E, Goyal D, Pattathu G N, Study on Reliability of Field-Aged Photovoltaic Connectors, *Eksploracja i Niezawodność – Maintenance and Reliability* 2025: 27(3) <http://doi.org/10.17531/ein/199496>

Study on Reliability of Field-Aged Photovoltaic Connectors

Kartik Kapoor^{a,*}, Eswaramoorthy Muthusamy^a, Devendra Goyal^b, Nikhil Pattathu G^c

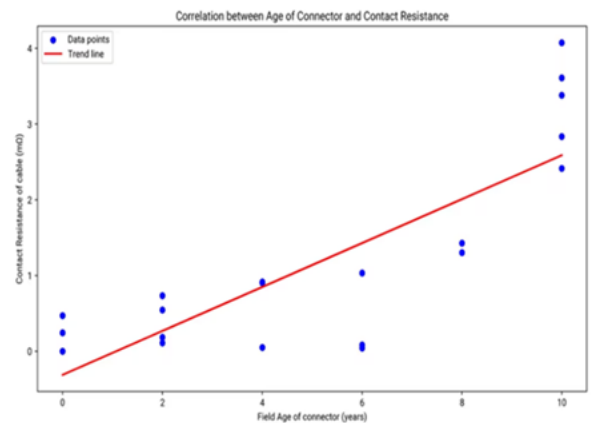
Figure 7. Depicts relationship of connector and contact resistance of cable.

Relationships between the field age of the connector and the contact resistance of the cable are shown in the scatter plots in the figure 7. The data points are presented in blue circles while a red trend line is drawn to show how the points are positively correlated. A field age correlation coefficient of 0.82 suggests that, as the field age of the connector increases, the contact resistance of the cable also increases significantly. This means that the older the connectors, the higher is the contact resistance. This is helpful in replacing and maintaining connectors with age for effective performance.

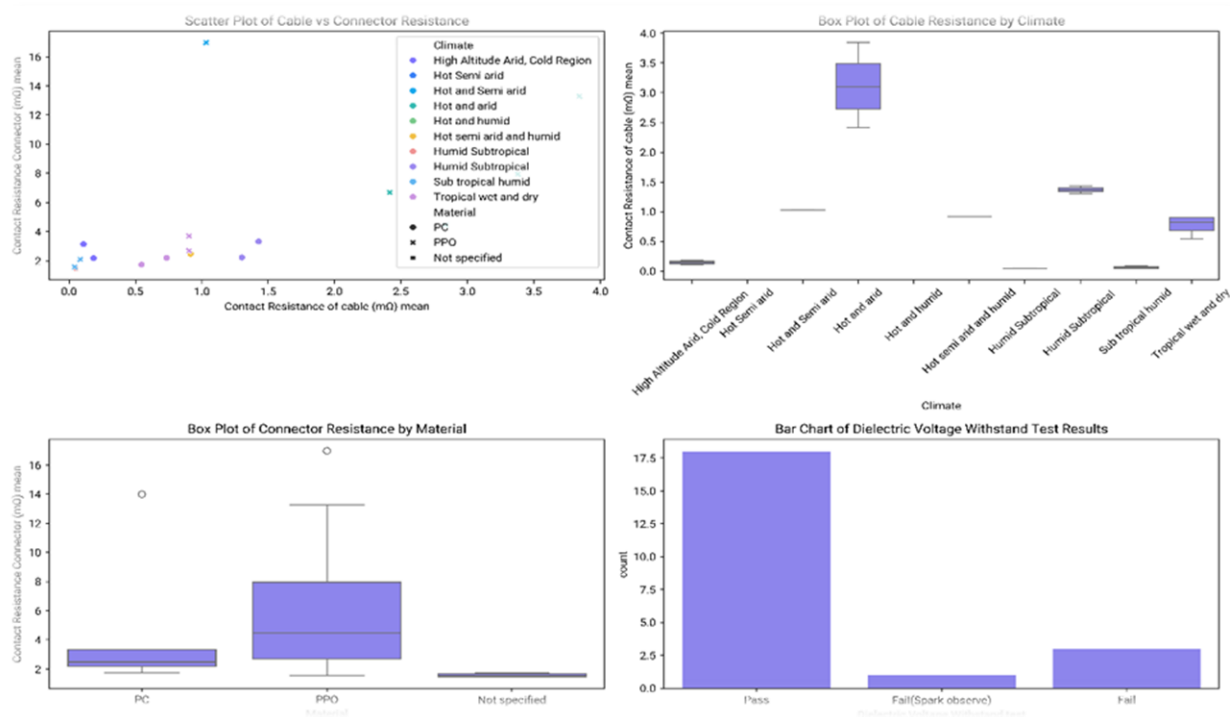
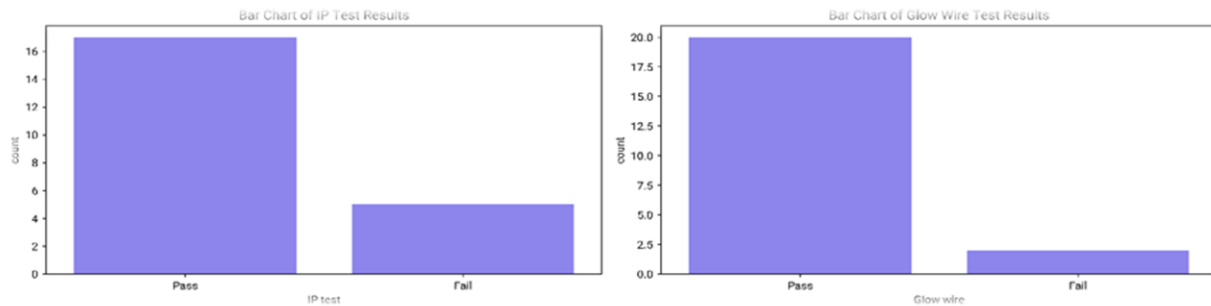
Also, the scatter plot at Figure 8 (a) tends to show a direct relationship between contact resistance of the cable as well as of the connector. It was observed that if there was high cable resistance, then the connector being used was likely to have higher resistance. These observations led to the box plot at Figure 8(b) inferring that region with climates “Hot and Semi-

Arid” and “Hot and Humid,” have high median values in terms of contact resistance of the cables. But “High Altitude Arid, (Cold Region)” appeared to deliver a wider range of resistance values. Resistance trends for the connector resistance were similarly exhibited except for the climatic regions of “Hot and Semi-Arid” and “Hot and Humid” which were recorded with higher resistance values.

The box plot shown in Figure 8(c) also shows that connectors made from PPO material have higher median contact resistance than those of connectors made from PC material. As shown in Figure 8(d), most of the samples pass the dielectric voltage withstand test, however, the samples which fail tend to show higher values of contact resistance. Most samples pass the IP test as depicted in Figure 8 (e), thus exhibiting effective ingress protection. However, samples which did not pass the IP test tend to have higher values of contact resistance. As seen in Figure 8(f), the majority of samples passed the glow wire test. Samples which fail this test have a tendency to have higher contact resistance values, which primarily suggests a relationship between poor thermal

Climates which are "hot and semi-arid" and "hot and humid" have also attributed higher values of contact resistance on both cables and connectors. The strong positive and negative correlations within specific locations such as Cochin, Kerala Deogarh, and Jharkhand suggest that outside environmental indices in these locations might significantly affect relationship existent between contact resistance and the IP test. Connectors made of PPO material tends to have higher resistance when compared with PC. It is also observed that higher contact resistance exist on samples which have lower values of insulation resistance and this suggests relationship that exists between poor insulation and contact resistance. The connectors which pass the dielectric voltage withstand test have minimal contact resistance values, indicating an increasing pattern where the contact resistance increases progressively with time, as well as with varying test conditions. Though connectors that pass the dielectric voltage withstand test, there is a progressive increase in contact resistance over time, but the values remain lower compared to those that fail.

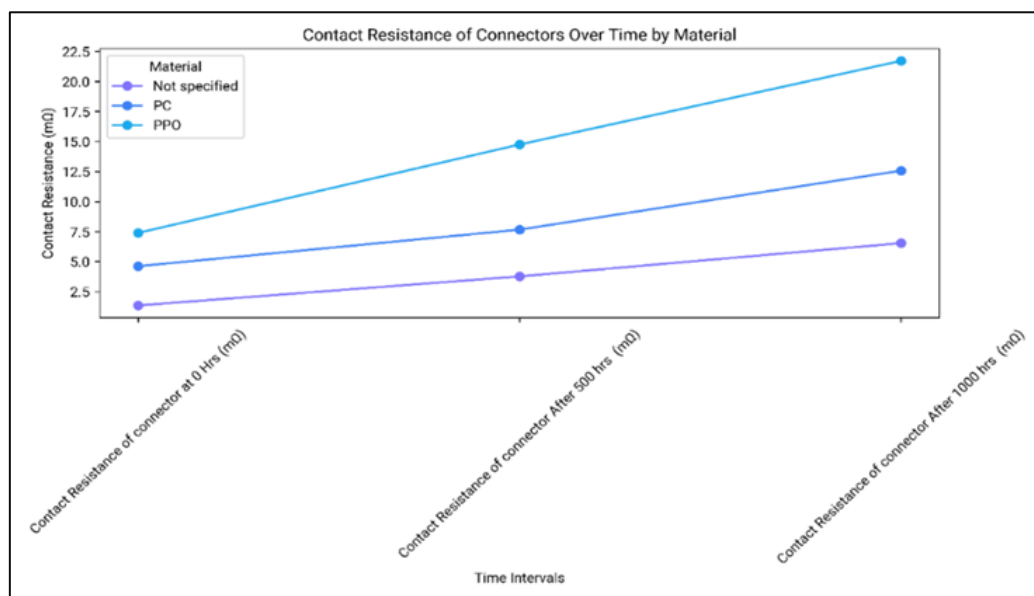
Figure 10. Depicts contact resistance of 12 connectors over time by material, climate and location during Thermal Cycle testing of 1000 hours.

of connectors, based on its region, climate and material, changes with time. It is seen that the connector made of PPO material had a increased value of contact resistance. It begins at almost 7.5 mΩ at 0 hours to around 22.5 mΩ after 1000 hours. On the other hand, PC material does a better job as it starts out at around 5 mΩ at 0 hours before increasing to approximately 15 mΩ in 1000 hours. The way the connectors are made bears a lot of significance to the contact resistance and its change over time. Out of the three connector materials, the PPO connectors record the highest increase followed by PC. However, contact resistance increases with time for all materials indicating a possible wearing out, or degradation over time.

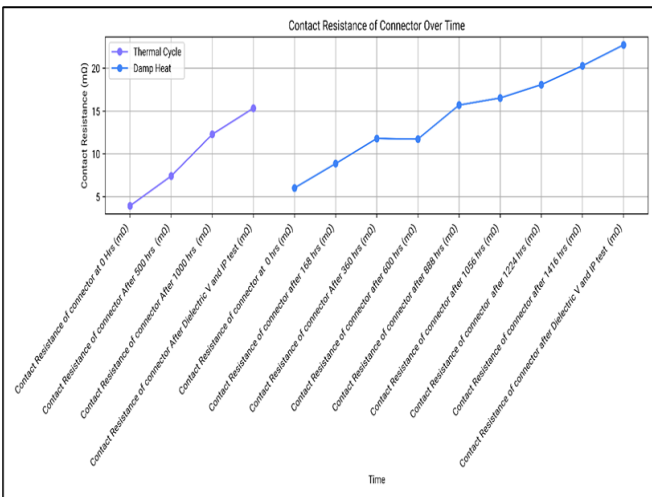
Figure 12. Plotting of contact resistance over time during thermal cycle and damp heat test.

Contact Resistance of Connector. Contact resistance of the connector is contributed by various factors depending on the climatological and geographical context. This brings out that environmental factors play a critical role in the degradation of connectors over time as depicted in below Figure 12.

- Location and climatic impact: Places of Delhi and Jaipur with hot semi-arid climates observed higher contact resistance values, hence connectors within these climates tend to experience more abrasion which further means an increased amount of degradation over time.

- Time dependency: As factors become time dependent, it is observed that contact resistance of these particular areas increases on the whole in most climates, however, it is the harsher climates that have the largest increase over time.

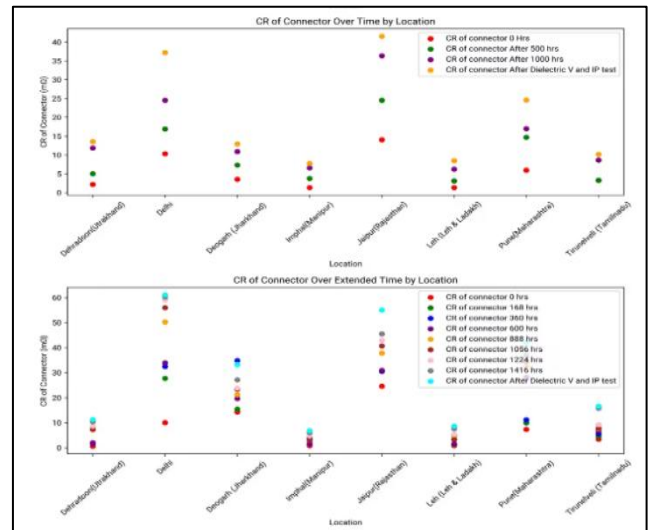
Figure 13. Analysis of contact resistance with location in thermal cycle and damp heat test.

Figure 13 depicts the study of contact resistance, which was observed to be higher for the damp heat dataset in the initial stage, 6.03 mΩ, compared to that for the thermal cycle dataset, 3.94 mΩ. The data from both datasets are shown to increase

with time; however, the increase for the damp heat dataset is more significant and it reached a maximum of 59 mΩ, whereas that of the thermal cycle dataset reached only 36.35 mΩ. After the dielectric voltage and IP test, the contact resistance is much higher in the damp heat than that in thermal cycle. The standard deviation is commonly higher in the damp heat dataset, indicating more variability within the contact resistance measurements. These results show that the conditions of damp heat have a more profound effect on the progression of contact resistance of the connector with time than those related to thermal cycling.
